**ADDENDUM NO. 1**

Date: August 29, 2018  
Project: **Secondary Treatment Plant Upgrade & Recycled Water Expansion**  
Job No.: 12600-07/16650-02

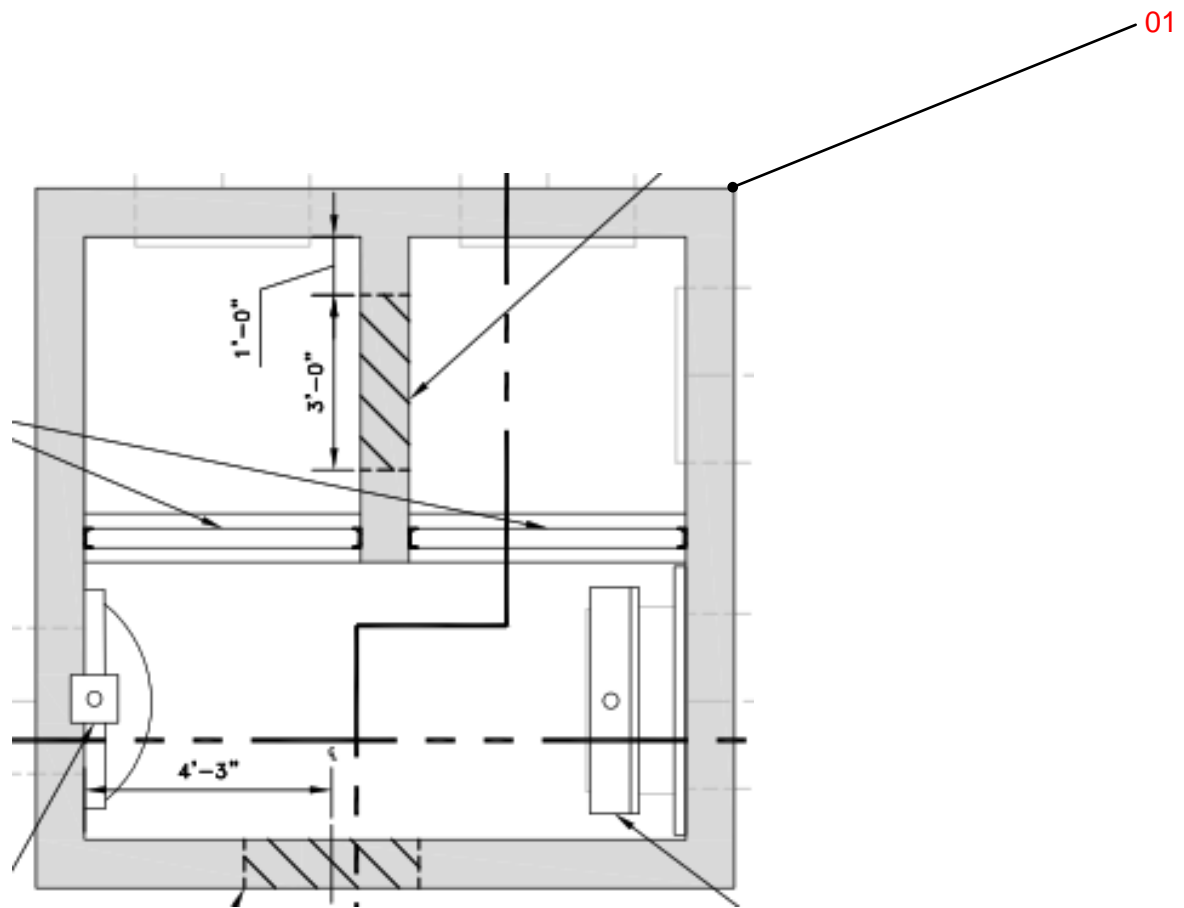
**SAMPLE LOCATION DRAWING**

Las Gallinas Valley Sanitary District  
 Demolition Plan Page C-27 (Contact Chamber Weir Box)  
 FACS # PJ38352  
 July 20, 2018 ADDENDUM 1

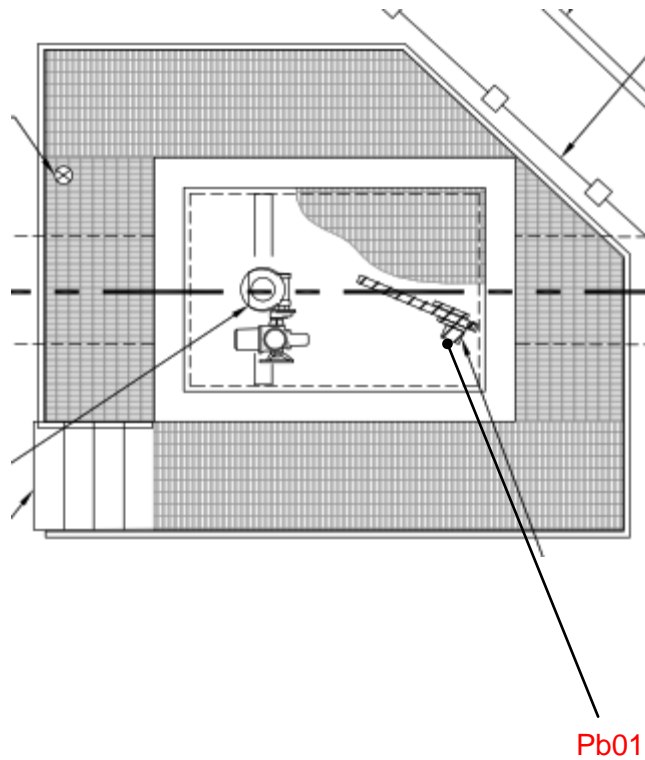
**SAMPLE LOCATION DRAWING**

Las Gallinas Valley Sanitary District  
 Demolition Plan Page C-32 (Outfall Box)  
 FACS # PJ38352  
 July 20, 2018

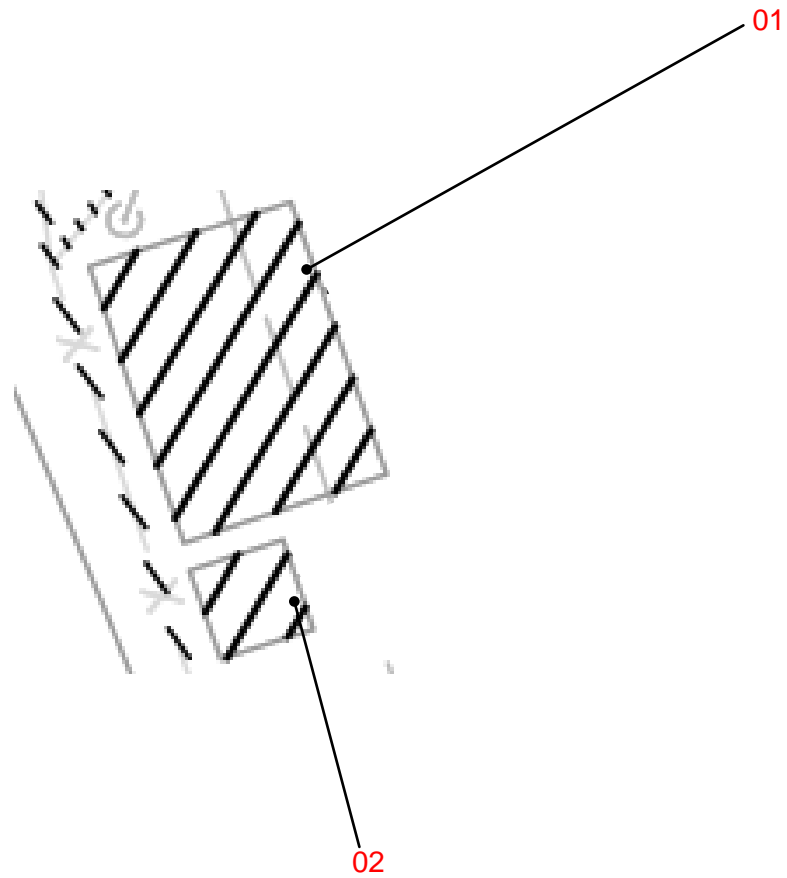
**SAMPLE LOCATION DRAWING**

Las Gallinas Valley Sanitary District  
 Demolition Plan Page D-1 (Equipment Pads)  
 FACS # PJ38352  
 July 20, 2018 ADDENDUM 1

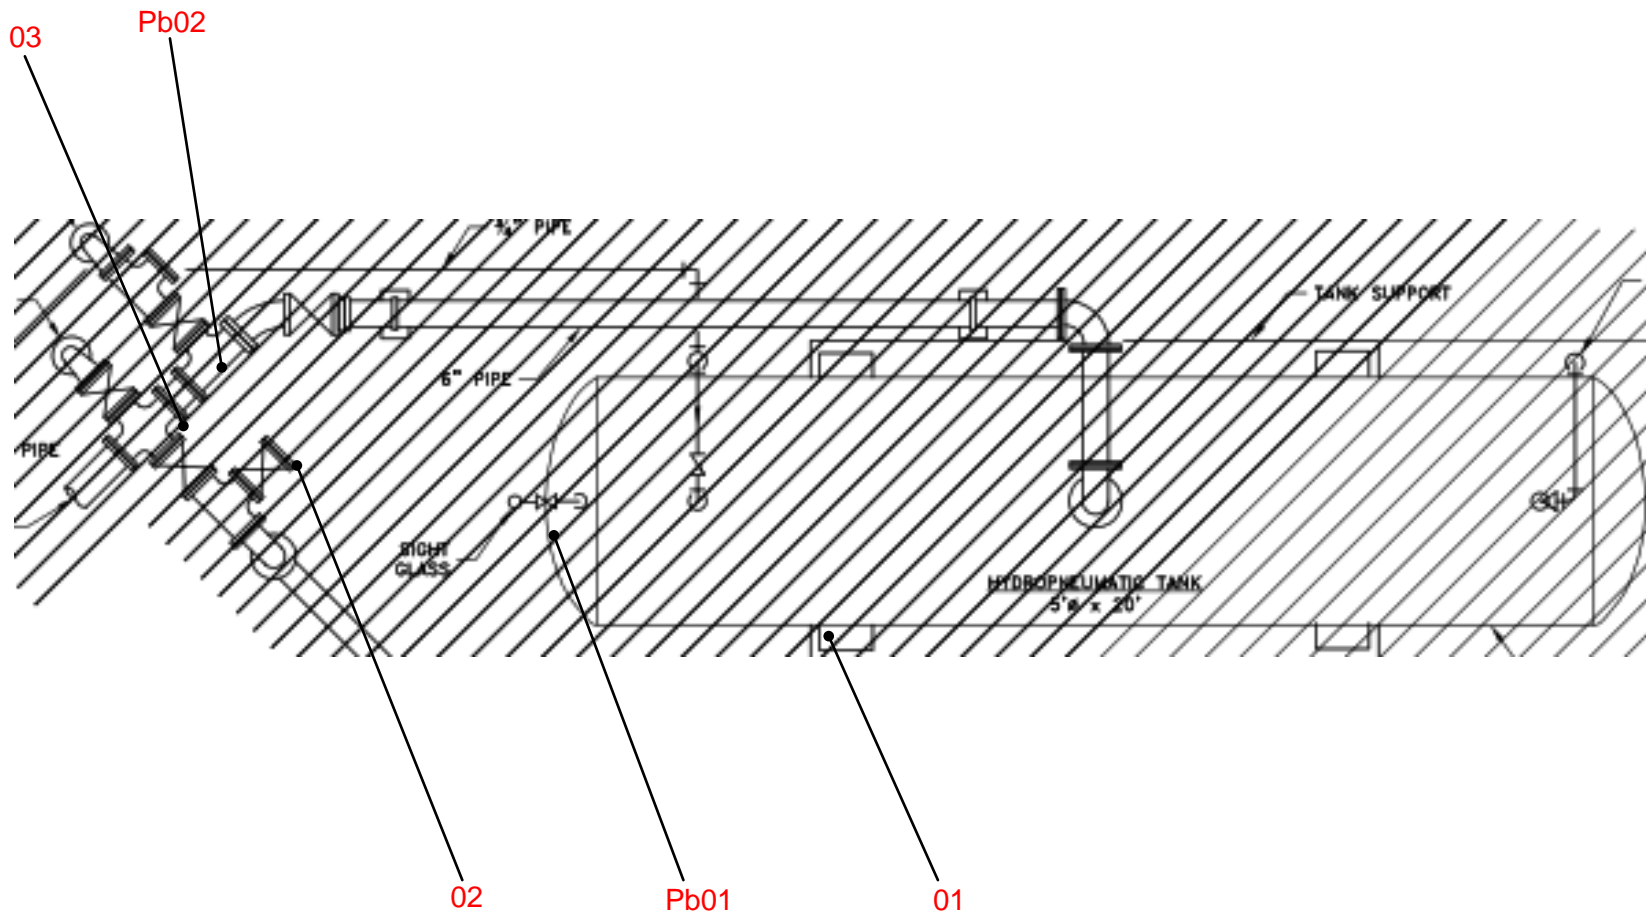
**SAMPLE LOCATION DRAWING**

Las Gallinas Valley Sanitary District  
 Demolition Plan Page D-11 (Hydropneumatic Tank)  
 FACS # PJ38352  
 July 20, 2018 ADDENDUM 1

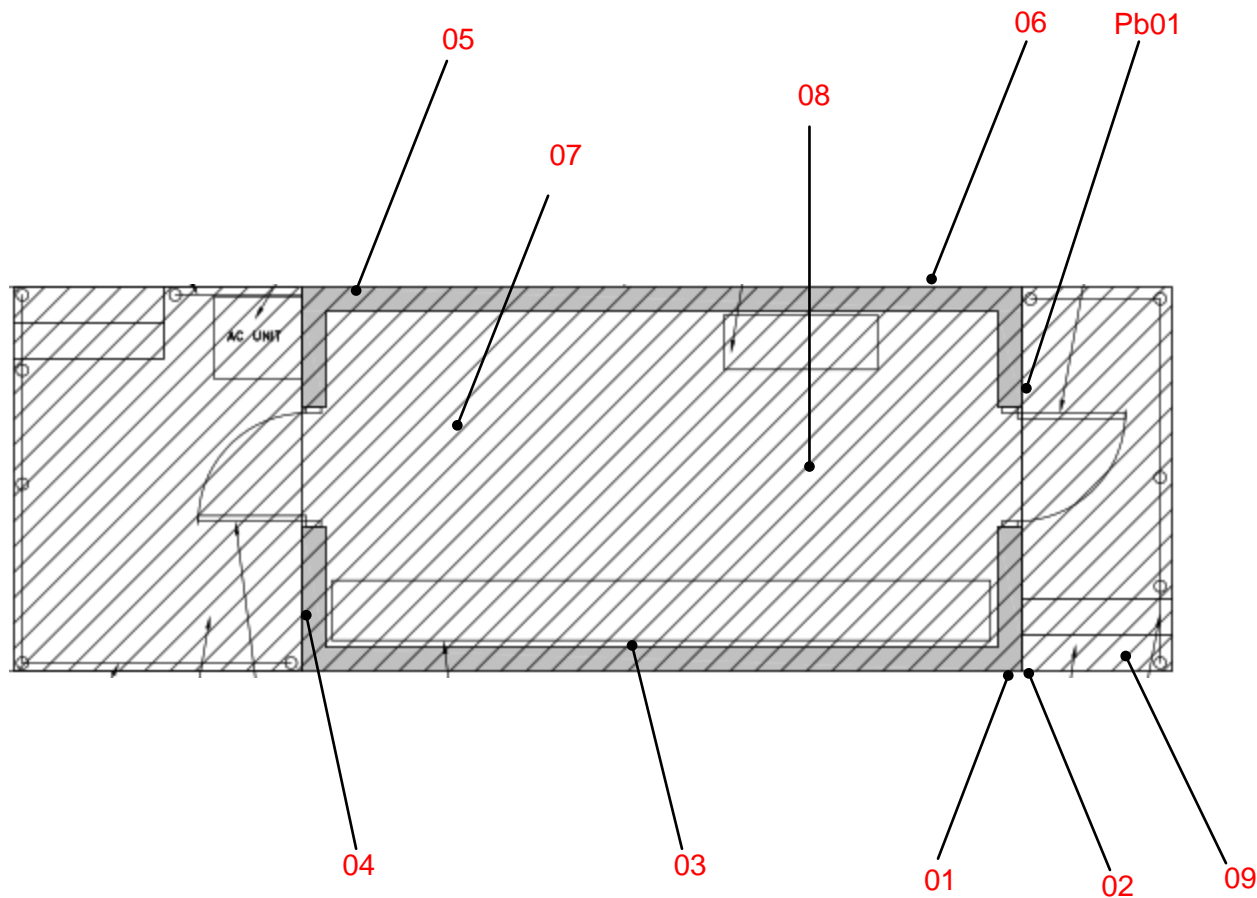
**SAMPLE LOCATION DRAWING**

Las Gallinas Valley Sanitary District  
 Demolition Plan Page D-12 (MCC #9 Building)  
 FACS # PJ38352  
 July 20, 2018 ADDENDUM 1

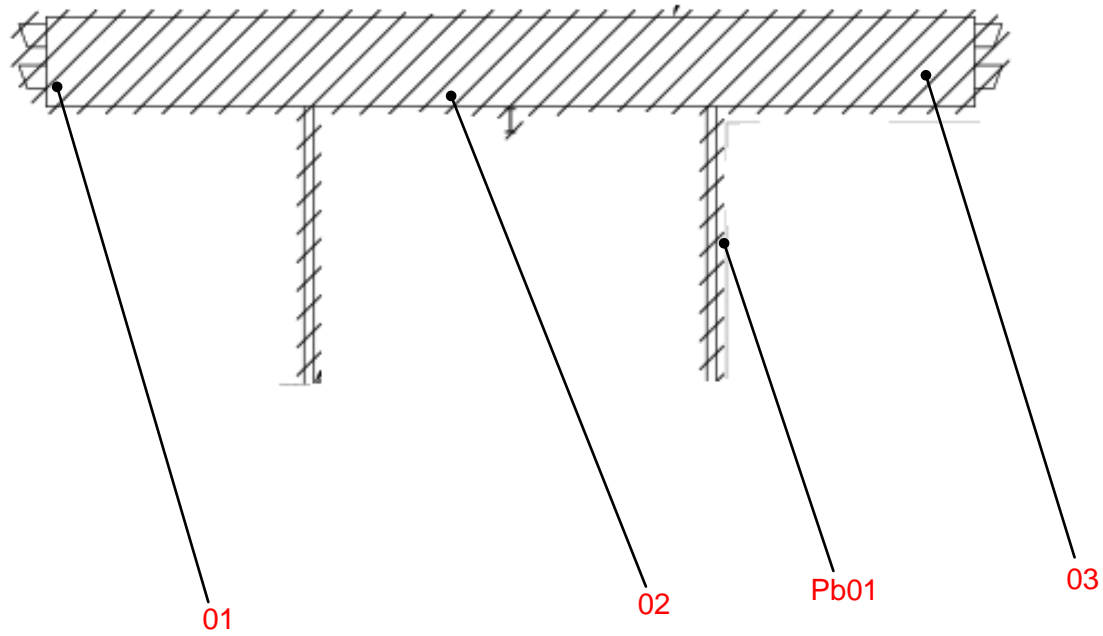
**SAMPLE LOCATION DRAWING**

Las Gallinas Valley Sanitary District  
 Demolition Plan Page D-13 (Canopy)  
 FACS # PJ38352  
 July 20, 2018

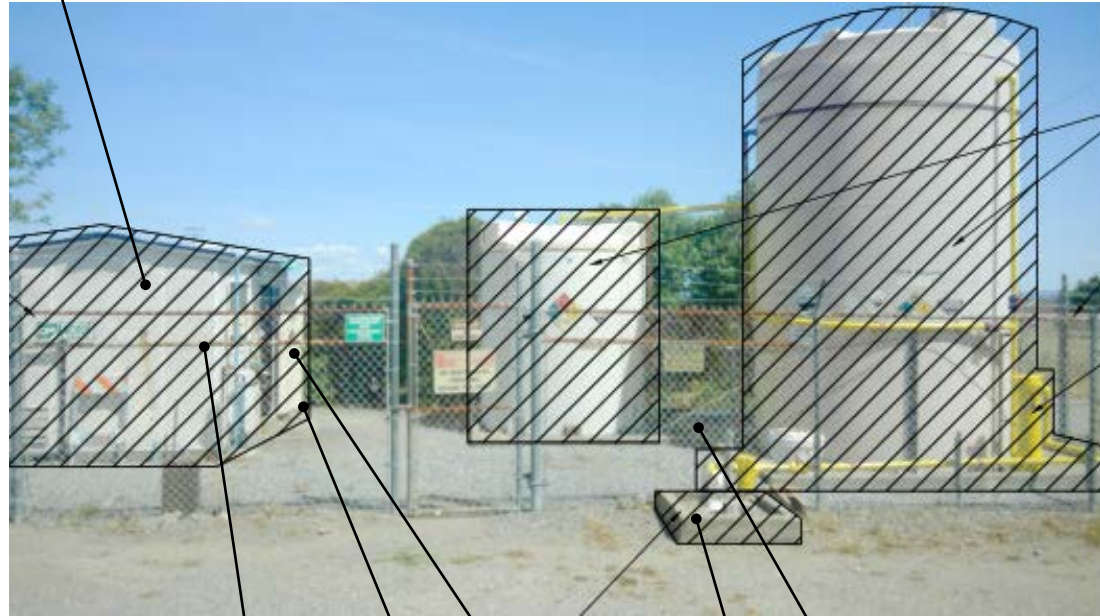
**SAMPLE LOCATION DRAWING**

Las Gallinas Valley Sanitary District  
 Demolition Plan Page D-14 (Dechlorination Pump and Storage  
 Area  
 FACS # PJ38352  
 ADDENDUM 1  
 July 20, 2018

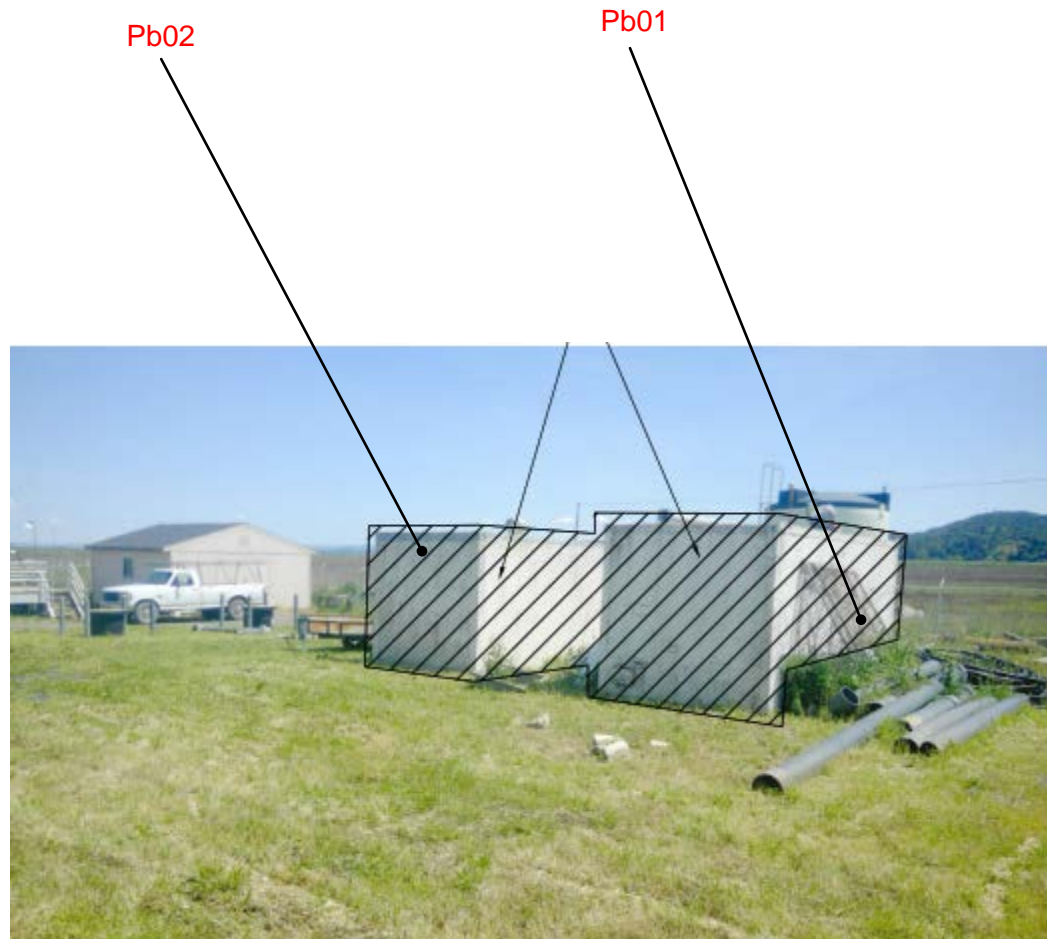
**SAMPLE LOCATION DRAWING**

Las Gallinas Valley Sanitary District  
Demolition Plan Page D-14 (Storage Containers)  
FACS # PJ38352  
July 20, 2018 ADDENDUM 1

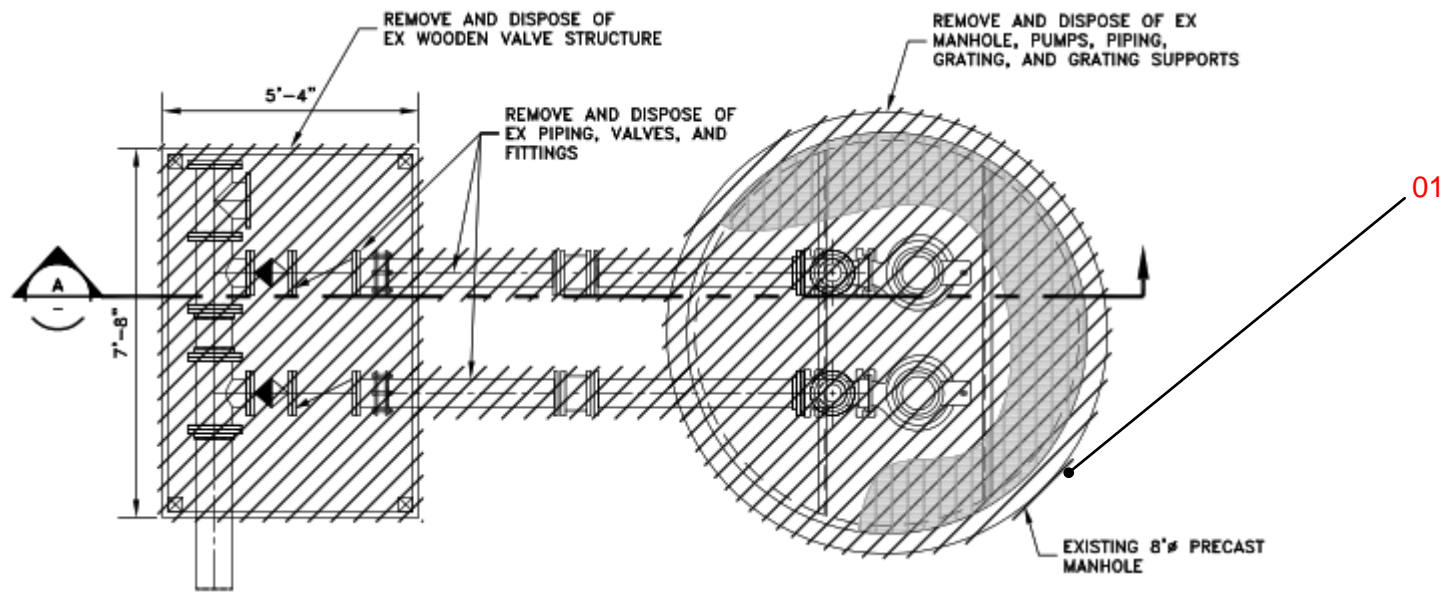
**SAMPLE LOCATION DRAWING**

Las Gallinas Valley Sanitary District  
 Demplition Plan Page D-15 (Stormwater Pump Station)  
 FACS # PJ38352  
 July 20, 2018 ADDENDUM 1

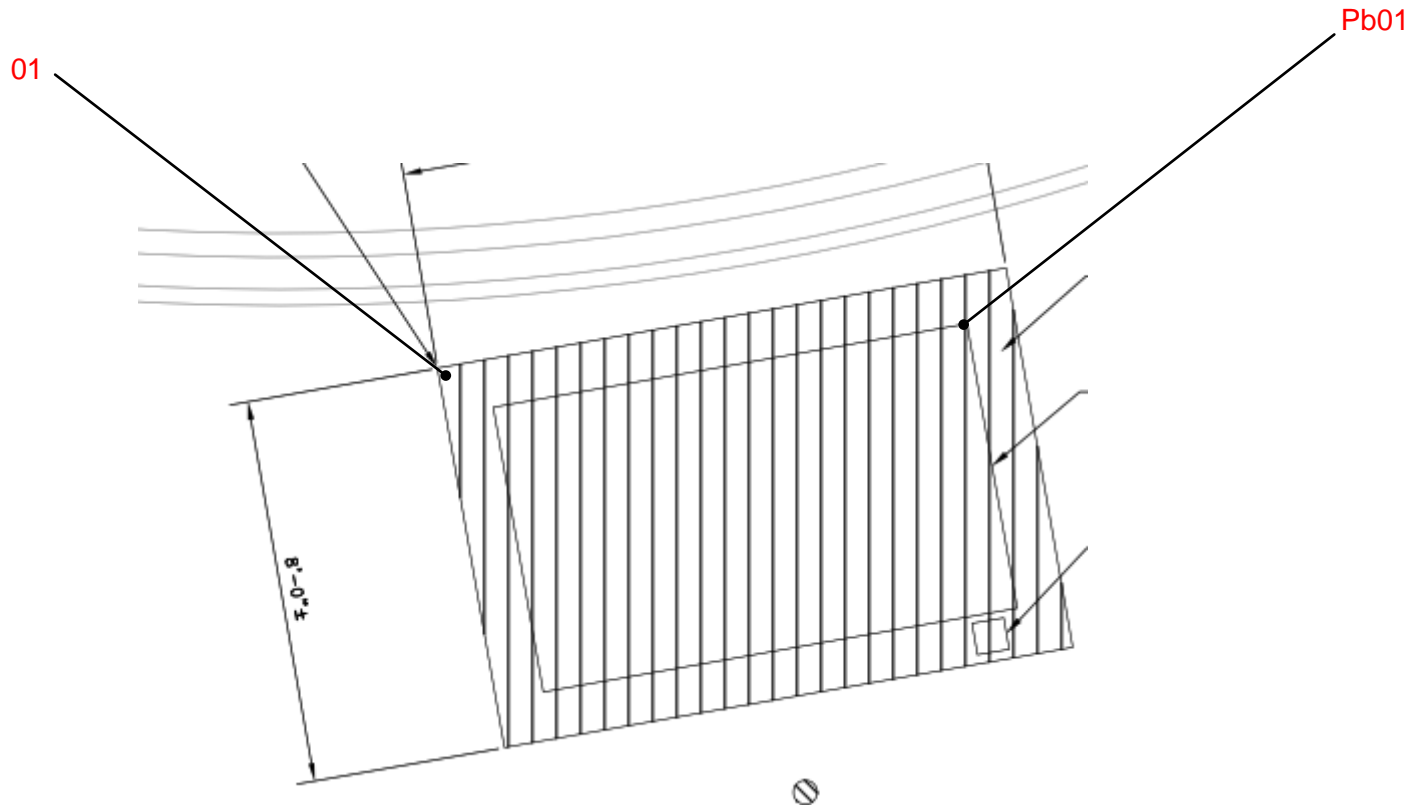
**SAMPLE LOCATION DRAWING**

Las Gallinas Valley Sanitary District  
 Demolition Plan Page D5 (Fuel Tank)  
 FACS # PJ38352  
 July 20, 2018

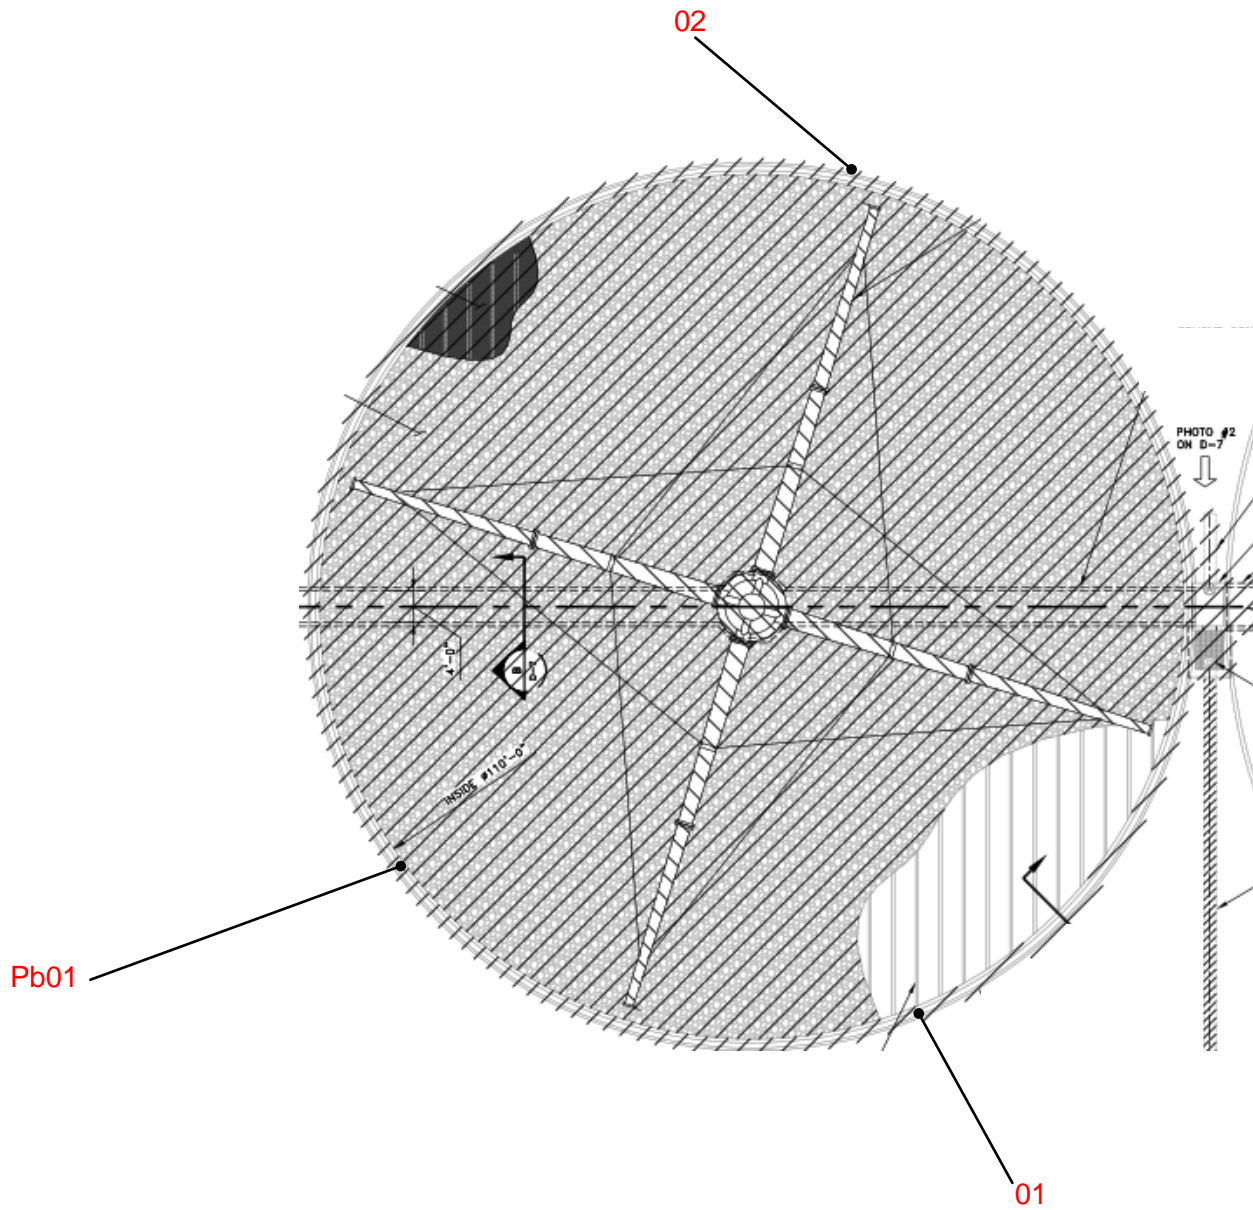
**SAMPLE LOCATION DRAWING**

Las Gallinas Valley Sanitary District  
 Demolition Plan Page D-6 (Primary Biofilter)  
 FACS # PJ38352  
 July 20, 2018 ADDENDUM 1

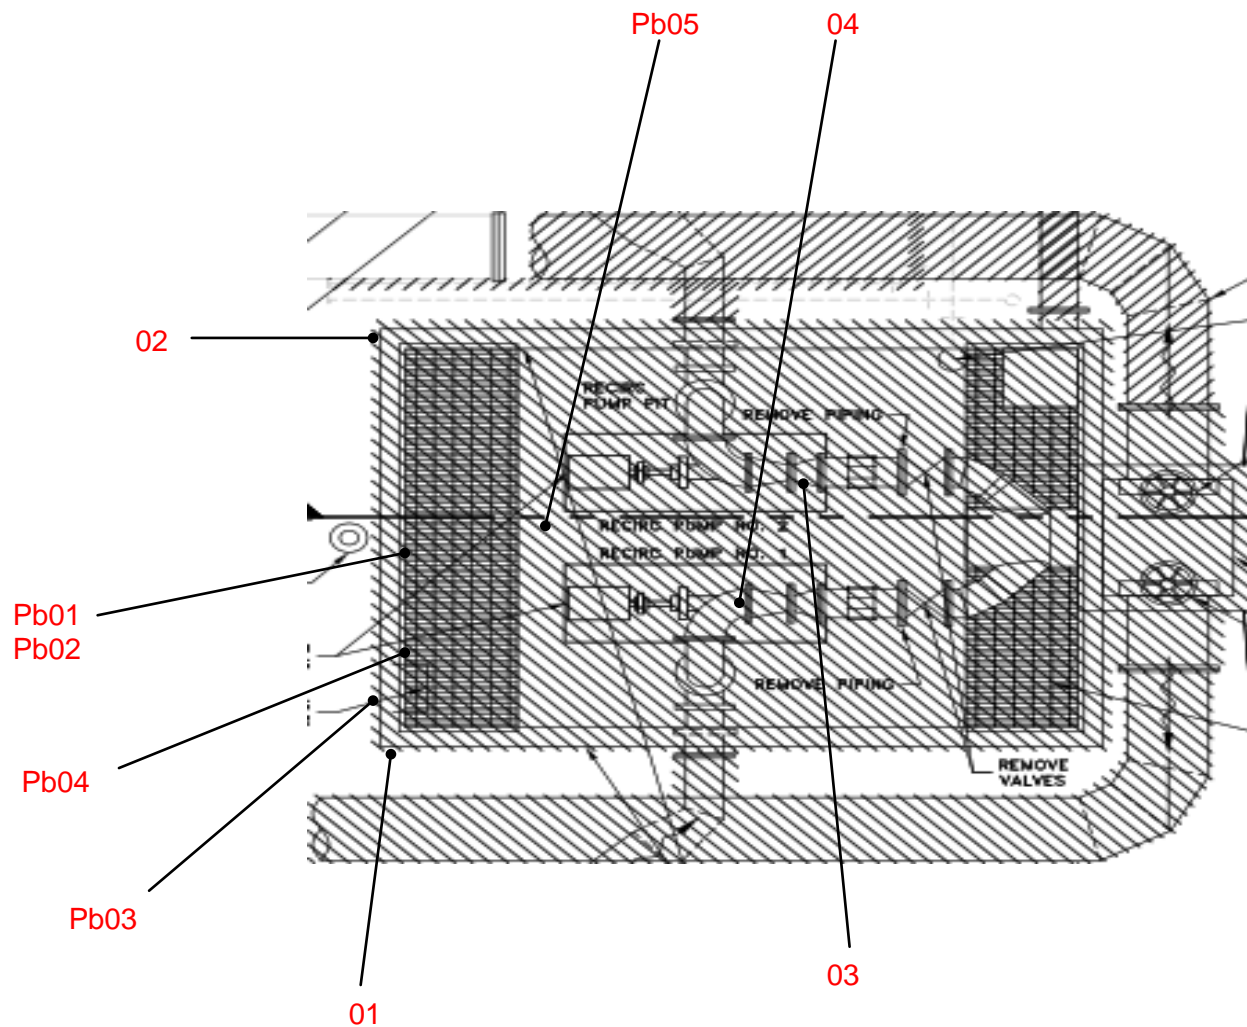
**SAMPLE LOCATION DRAWING**

Las Gallinas Valley Sanitary District  
 Demolition Plan Page D-8 (Boifilter Recirc Pump Pit)  
 FACS # PJ38352  
 July 20, 2018 ADDENDUM 1

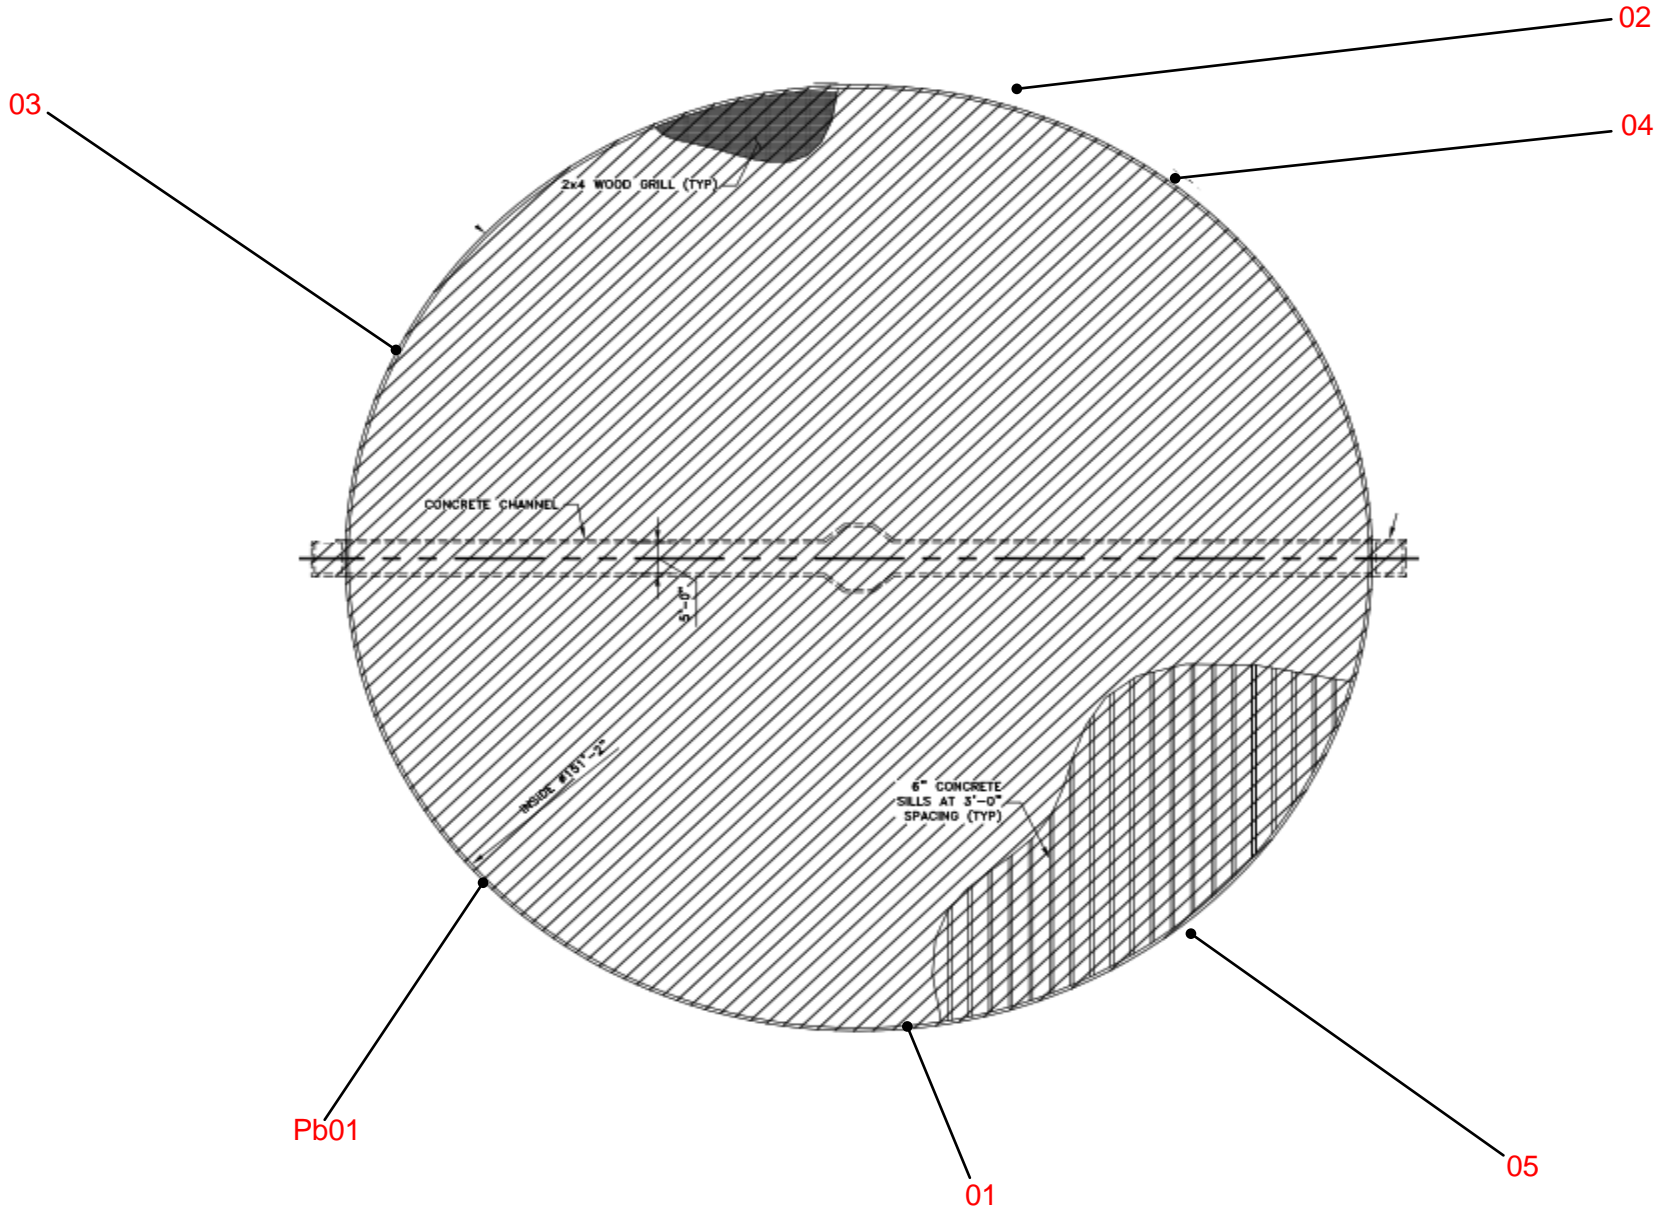
**SAMPLE LOCATION DRAWING**

Las Gallinas Valley Sanitary District  
 Demolition Plan Page D-9 (Secondary Biofilter)  
 FACS # PJ38352  
 July 20, 2018 ADDENDUM 1

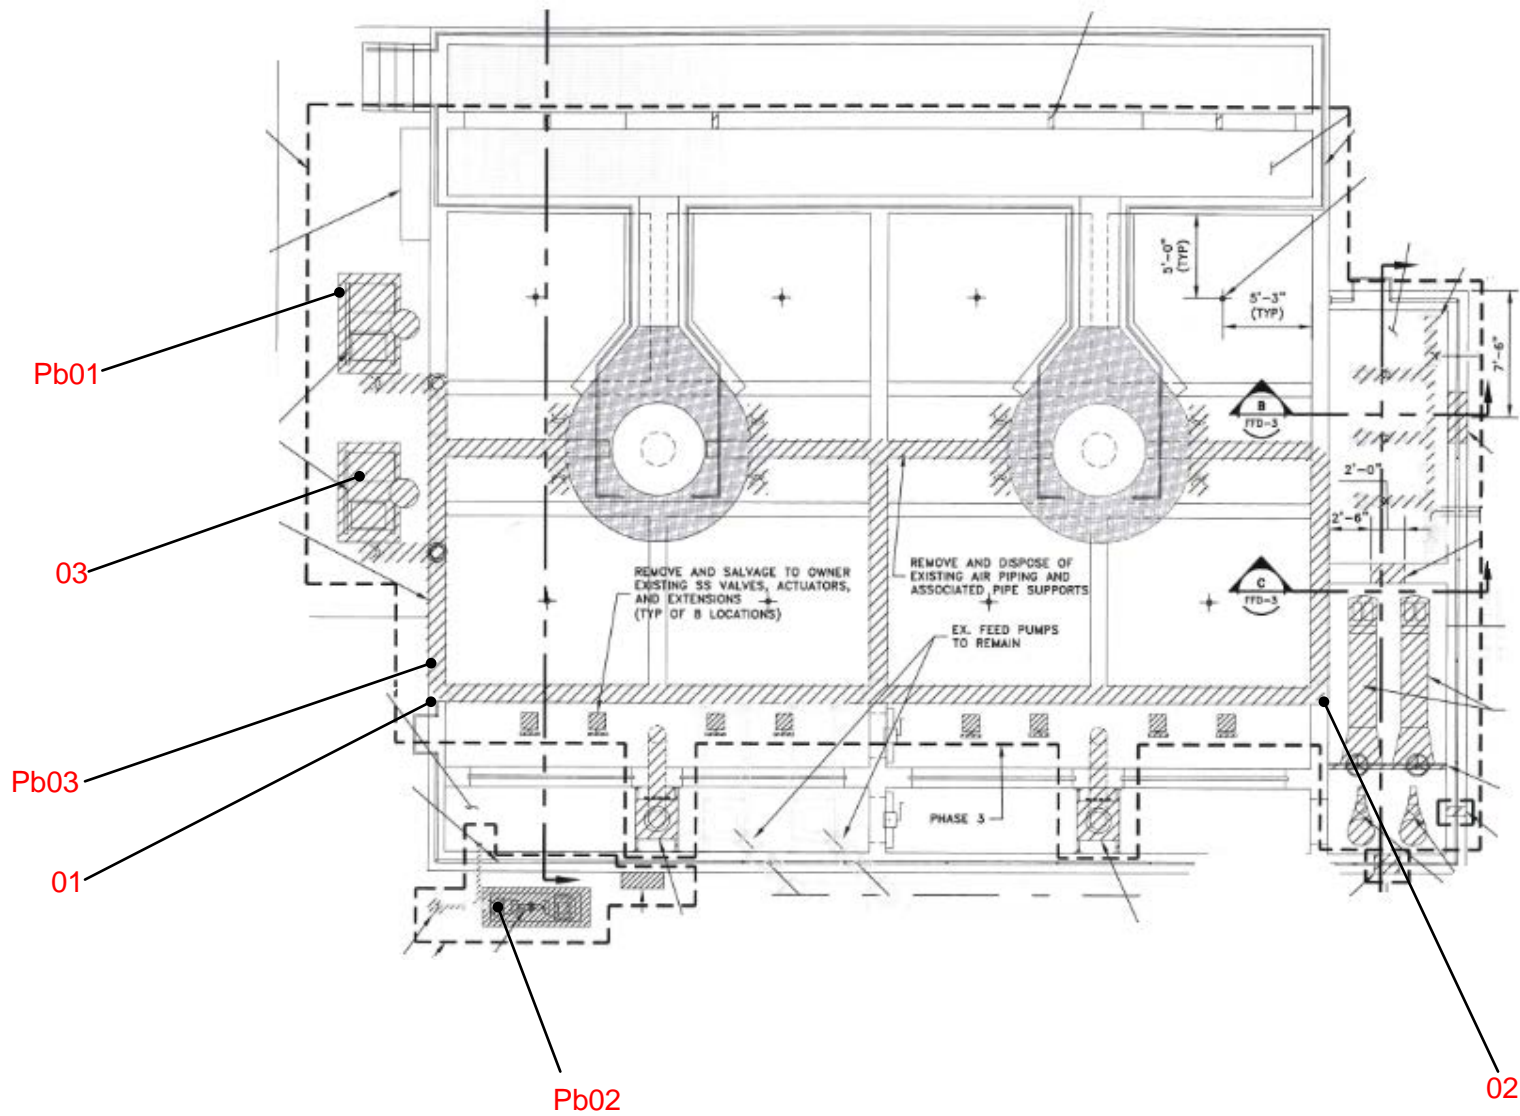
**SAMPLE LOCATION DRAWING**

Las Gallinas Valley Sanitary District  
 Demolition Plan Page FFD-1 (Filter Feed Pump Station)  
 FACS # PJ38352  
 July 20, 2018 ADDENDUM 1

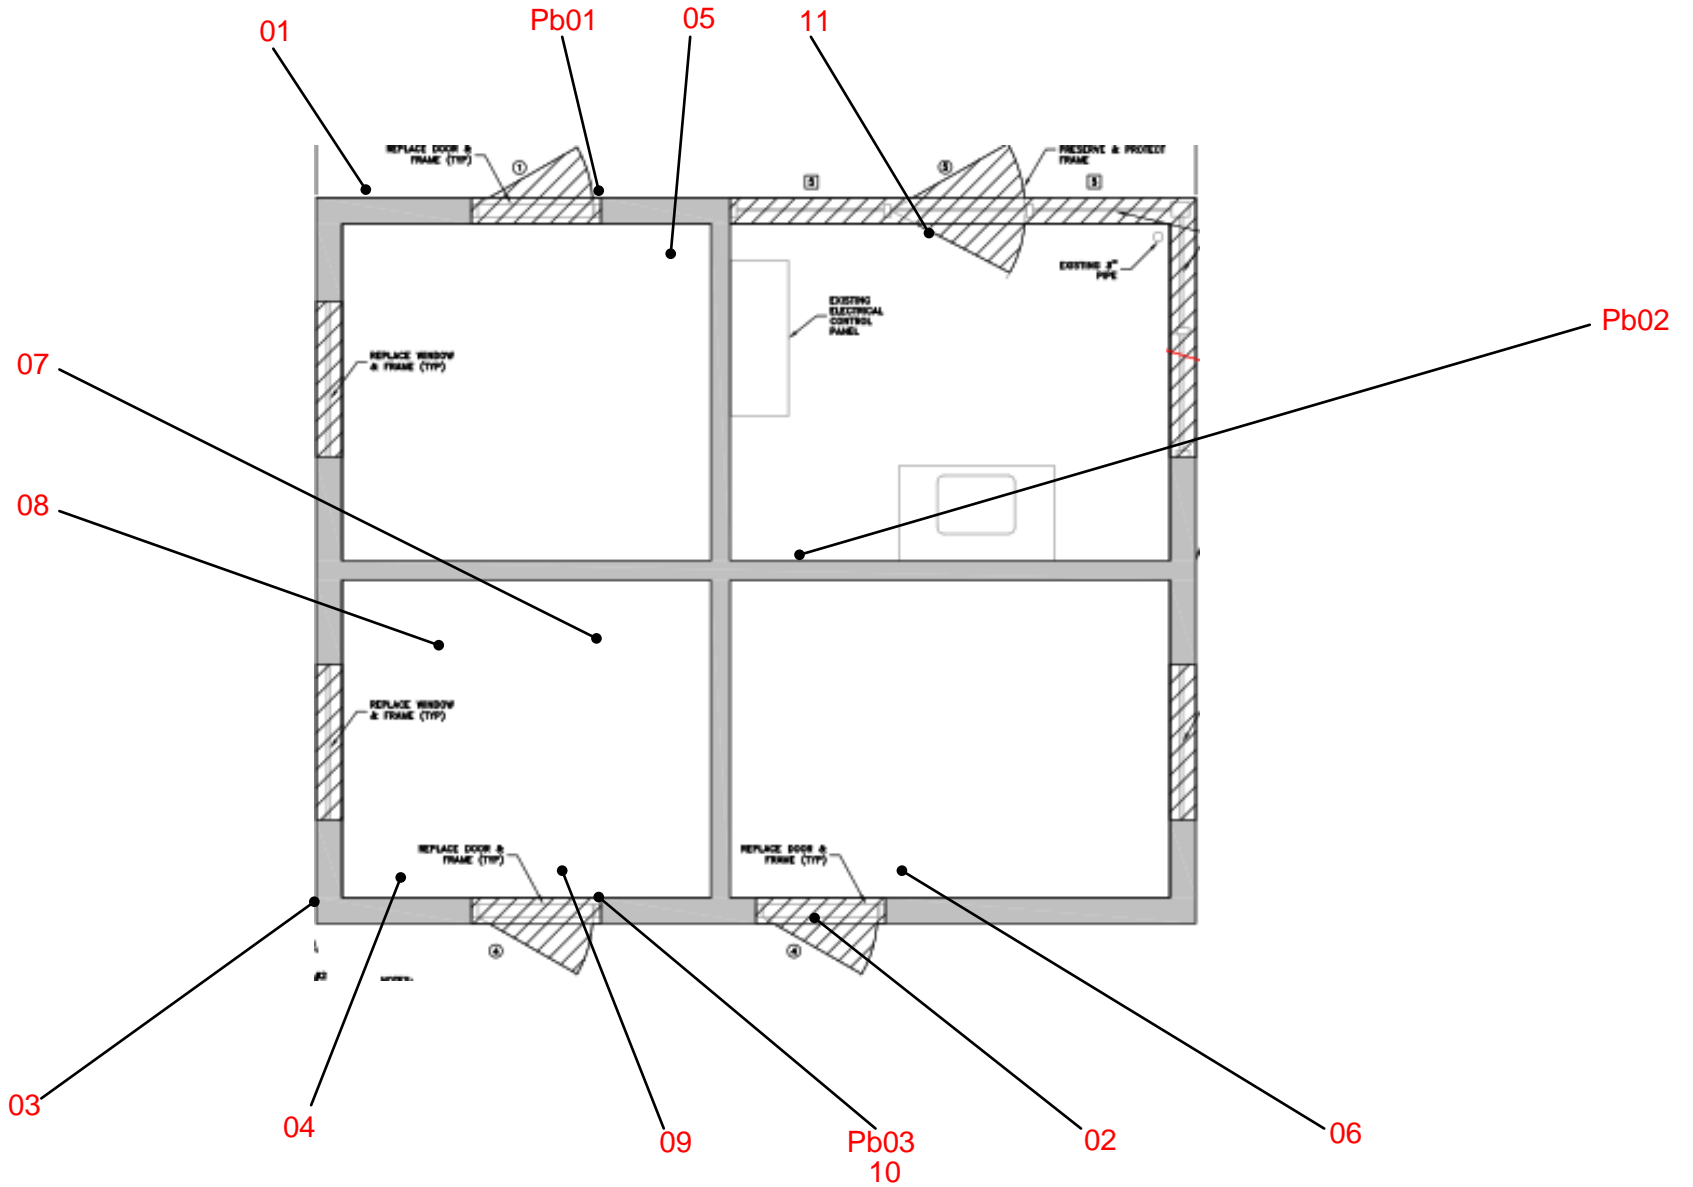
**SAMPLE LOCATION DRAWING**

Las Gallinas Valley Sanitary District  
 Demolition Plan Page MSB-1 (MCC #3 Building)  
 FACS # PJ38352  
 July 20, 2018 ADDENDUM 1

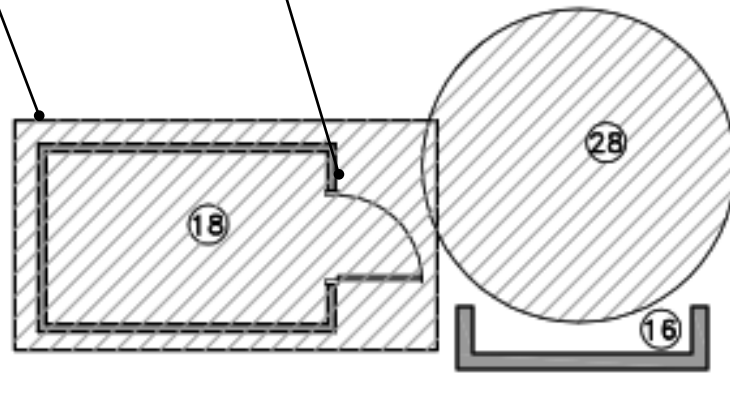
**SAMPLE LOCATION DRAWING**

Las Gallinas Valley Sanitary District  
Demolition Plan Page MMD-1 (Chlorination House & Poly Tank 28)  
FACS # PJ38352  
July 20, 2018  
ADDENDUM 1

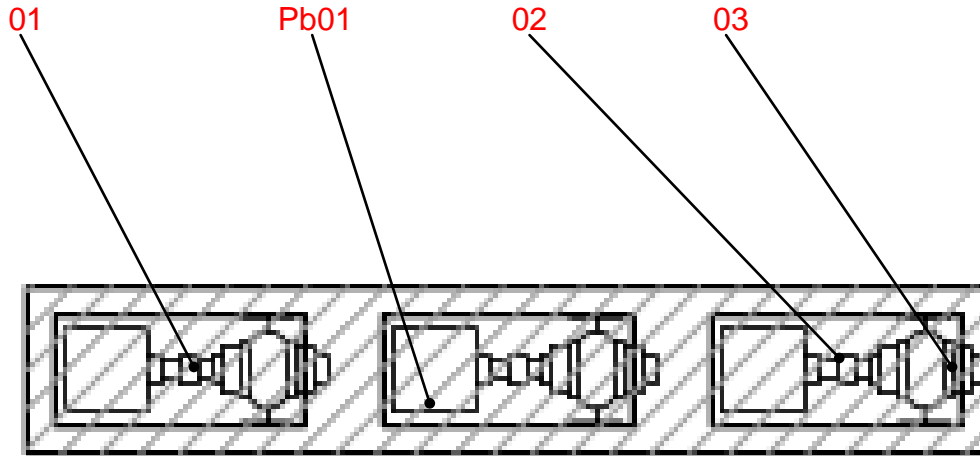
**SAMPLE LOCATION DRAWING**

Las Gallinas Valley Sanitary District  
 Demolition Plan Page MMD-1 (Product Pump 15)  
 FACS # PJ38352  
 July 20, 2018

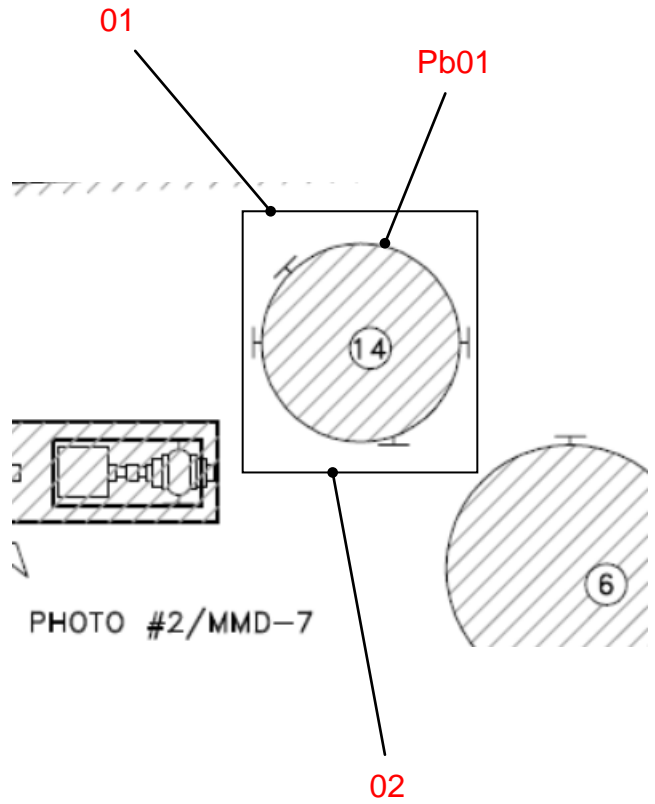
**SAMPLE LOCATION DRAWING**

Las Gallinas Valley Sanitary District  
 Demolition Plan Page - MMD-1 (Product Weir Tank – 14)  
 FACS # PJ38352  
 July 20, 2018

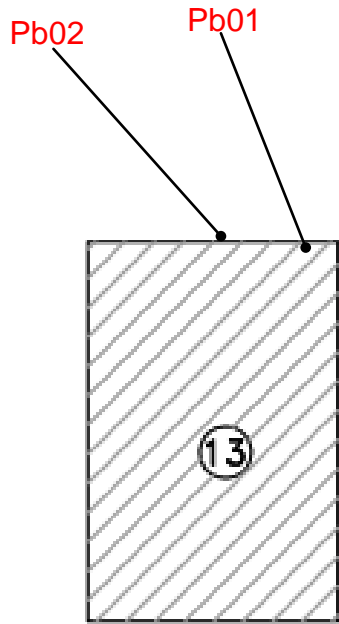
**SAMPLE LOCATION DRAWING**

Las Gallinas Valley Sanitary District  
Demolition Plan Page MMD-1 (Hydropneumatic Tank Shed - 13)  
FACS # PJ38352  
July 20, 2018

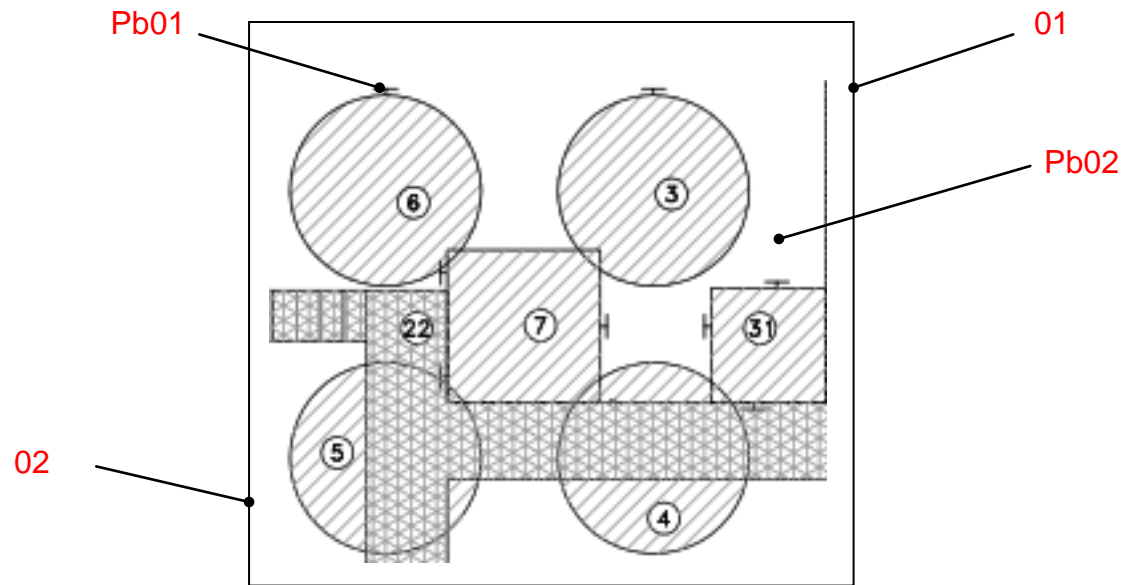
**SAMPLE LOCATION DRAWING**

Las Gallinas Valley Sanitary District  
 Demolition Plan Page MMD-1 (Tanks 3-6 area)  
 FACS # PJ38352  
 July 20, 2018 ADDENDUM 1

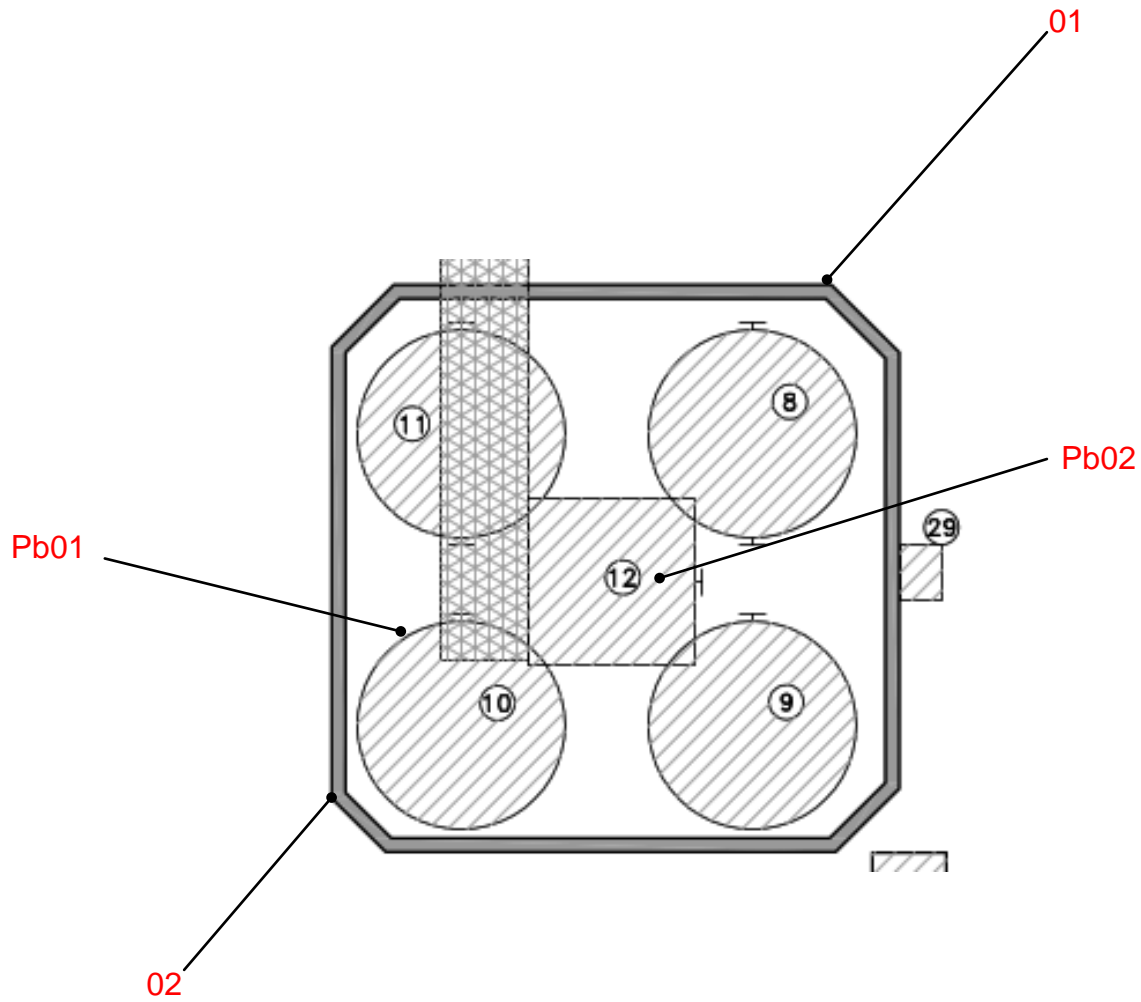
**SAMPLE LOCATION DRAWING**

Las Gallinas Valley Sanitary District  
 Demolition Plan Page MMD-1 (Tanks 8-11 Area)  
 FACS # PJ38352  
 July 20, 2018  
 ADDENDUM 1
