**ADDENDUM NO. 1**

Date: August 29, 2018  
Project: **Secondary Treatment Plant Upgrade & Recycled Water Expansion**  
Job No.: 12600-07/16650-02

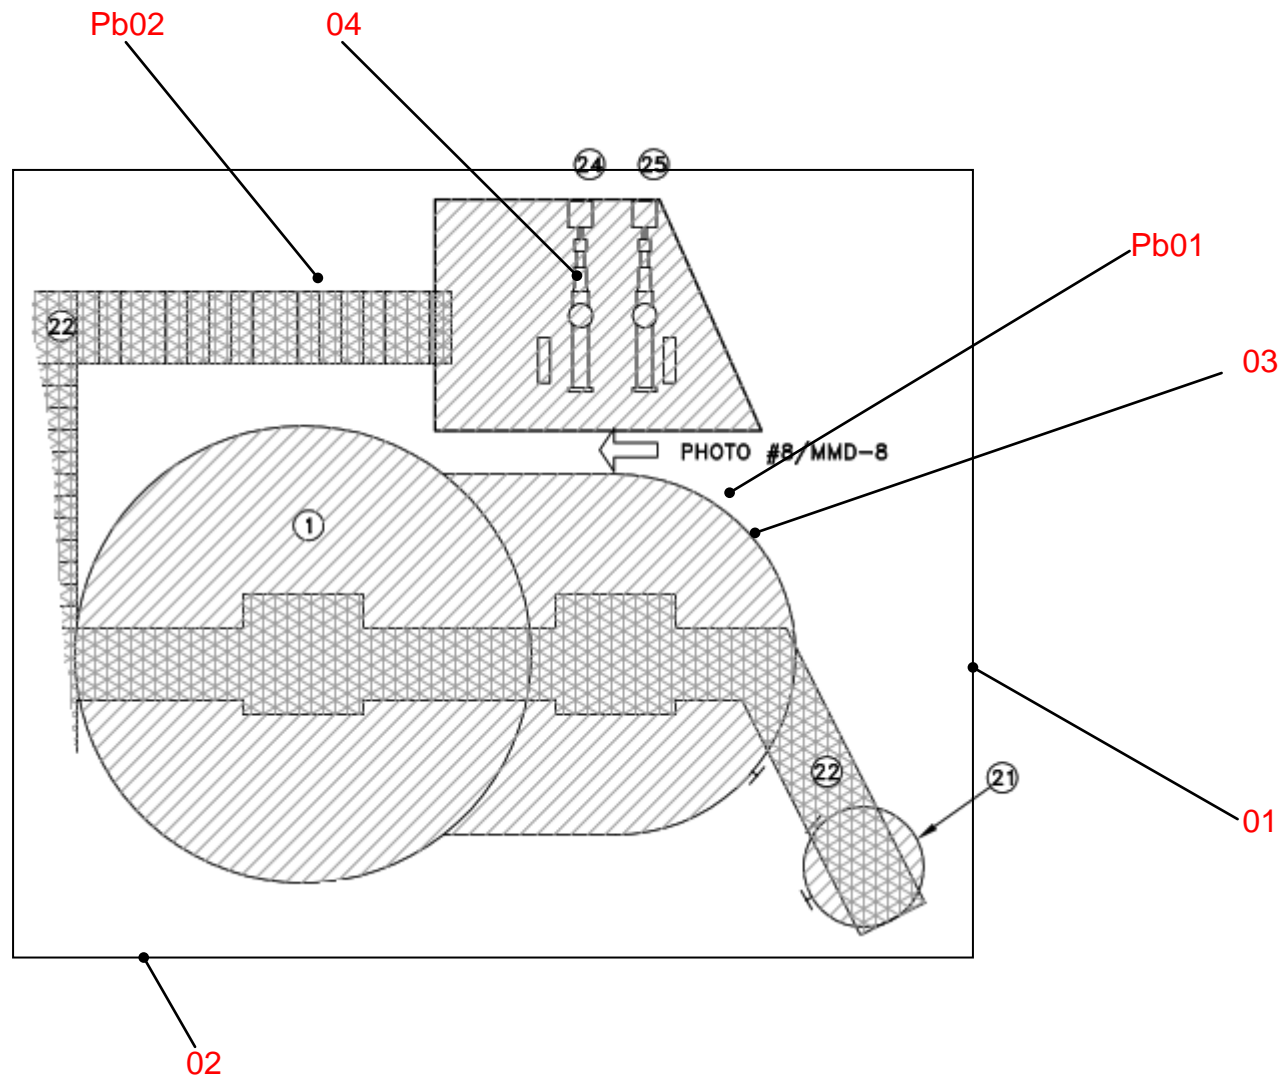
**SAMPLE LOCATION DRAWING**

Las Gallinas Valley Sanitary District  
 Demolition Plan Page MMD-1 (Tank 1 Area)  
 FACS # PJ38352  
 July 20, 2018 ADDENDUM 1

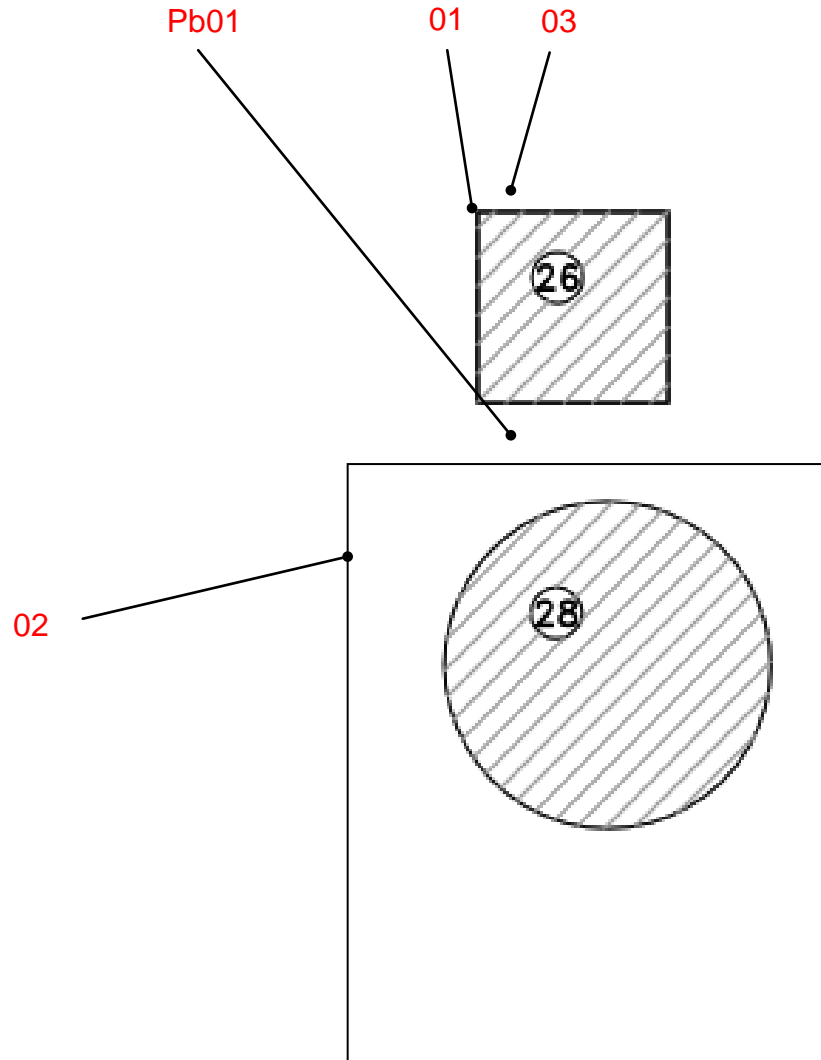
**SAMPLE LOCATION DRAWING**

Las Gallinas Valley Sanitary District  
 Demolition Plan Page MMD-1 (Tank Area 26/28)  
 FACS # PJ38352  
 July 20, 2018

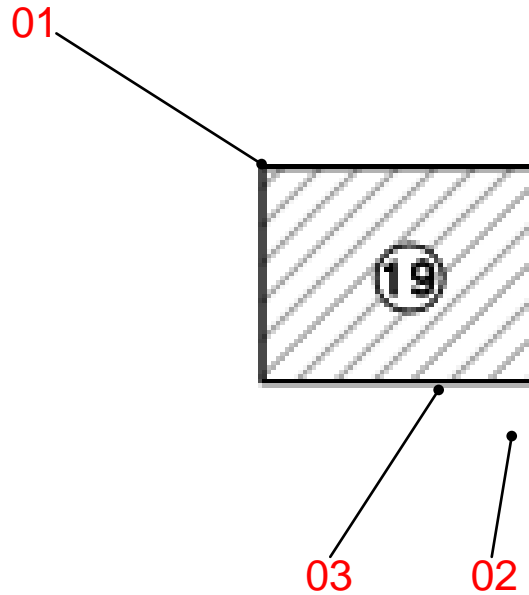
**SAMPLE LOCATION DRAWING**

Las Gallinas Valley Sanitary District  
Demolition Plan Page MMD-1 (Zinc Pump House – 19)  
FACS # PJ38352  
July 20, 2018

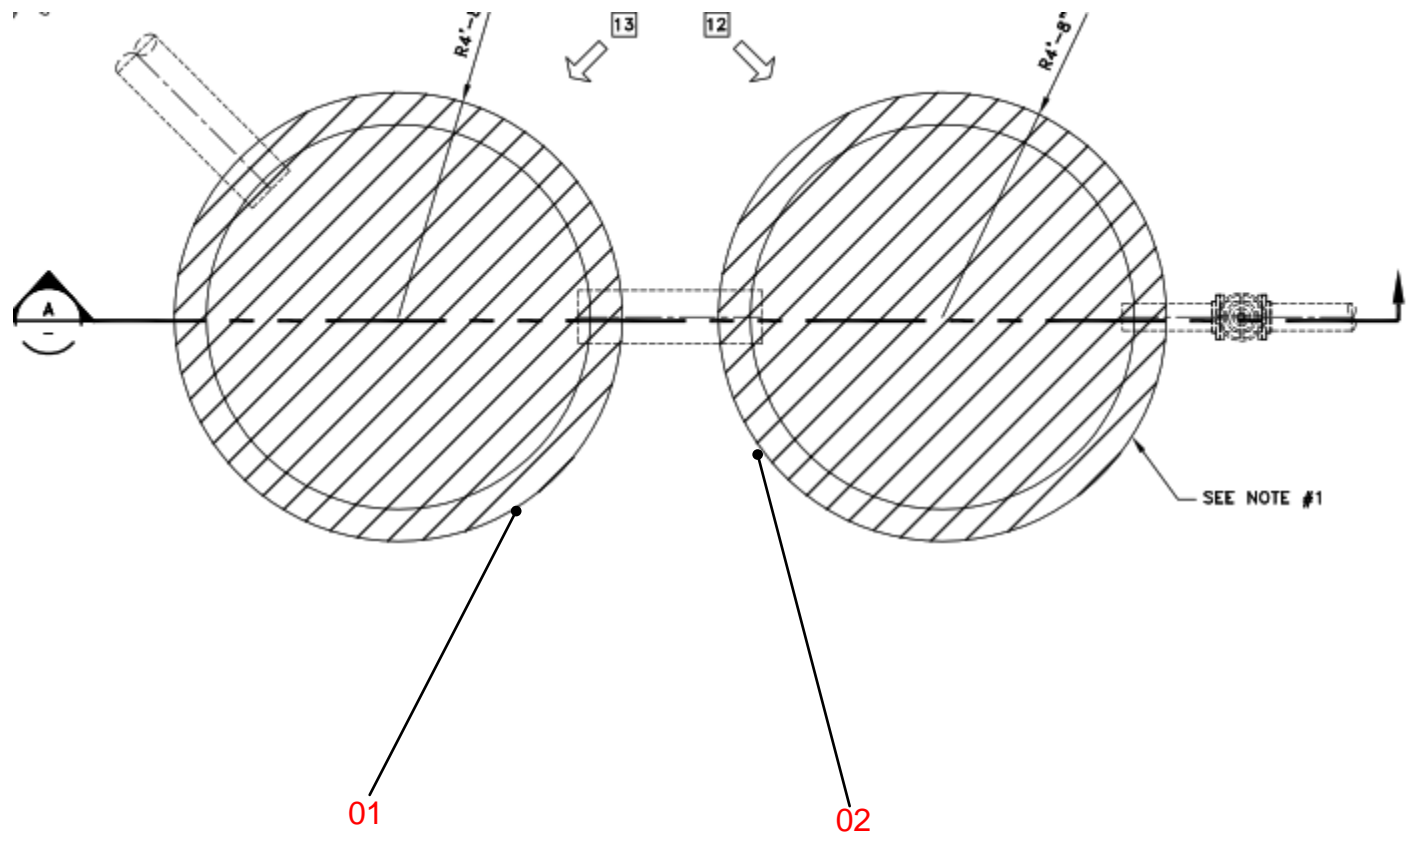
**SAMPLE LOCATION DRAWING**

Las Gallinas Valley Sanitary District  
 Demolition Plan Page MMD-2 (Backwash Sump)  
 FACS # PJ38352  
 July 20, 2018 ADDENDUM 1

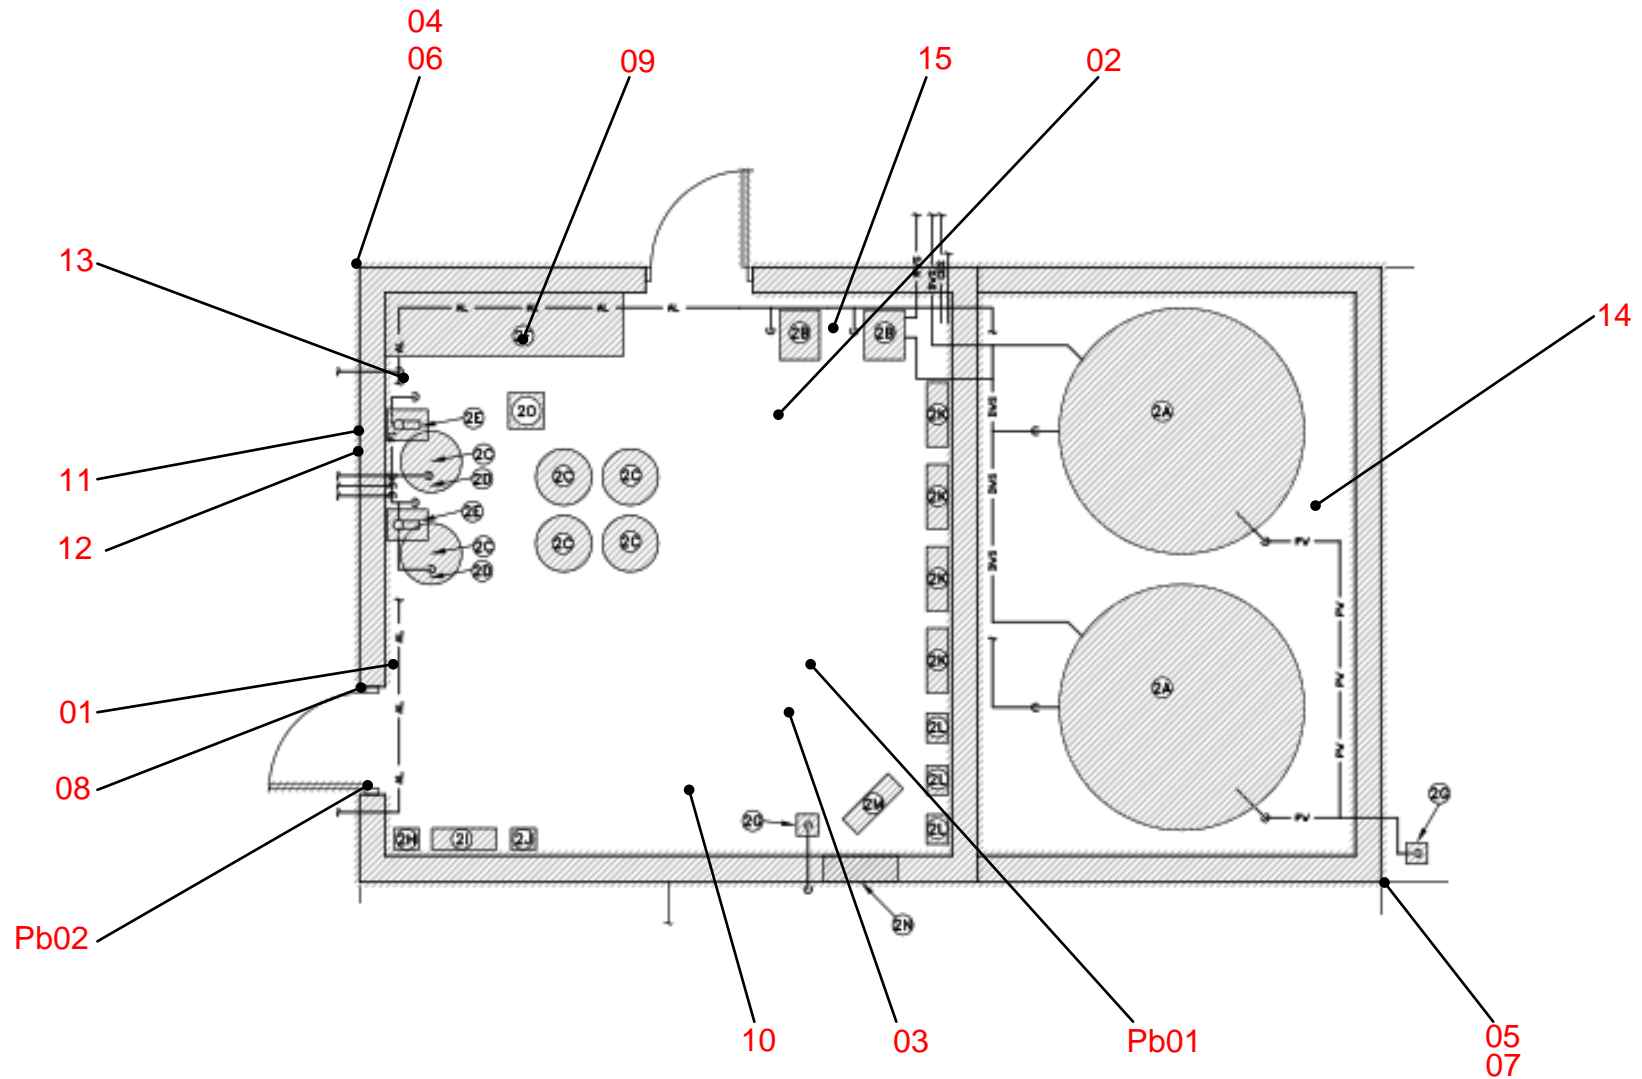
**SAMPLE LOCATION DRAWING**

Las Gallinas Valley Sanitary District  
 Demolition Plan Page MMD-3 (Chemical Building)  
 FACS # PJ38352  
 July 20, 2018

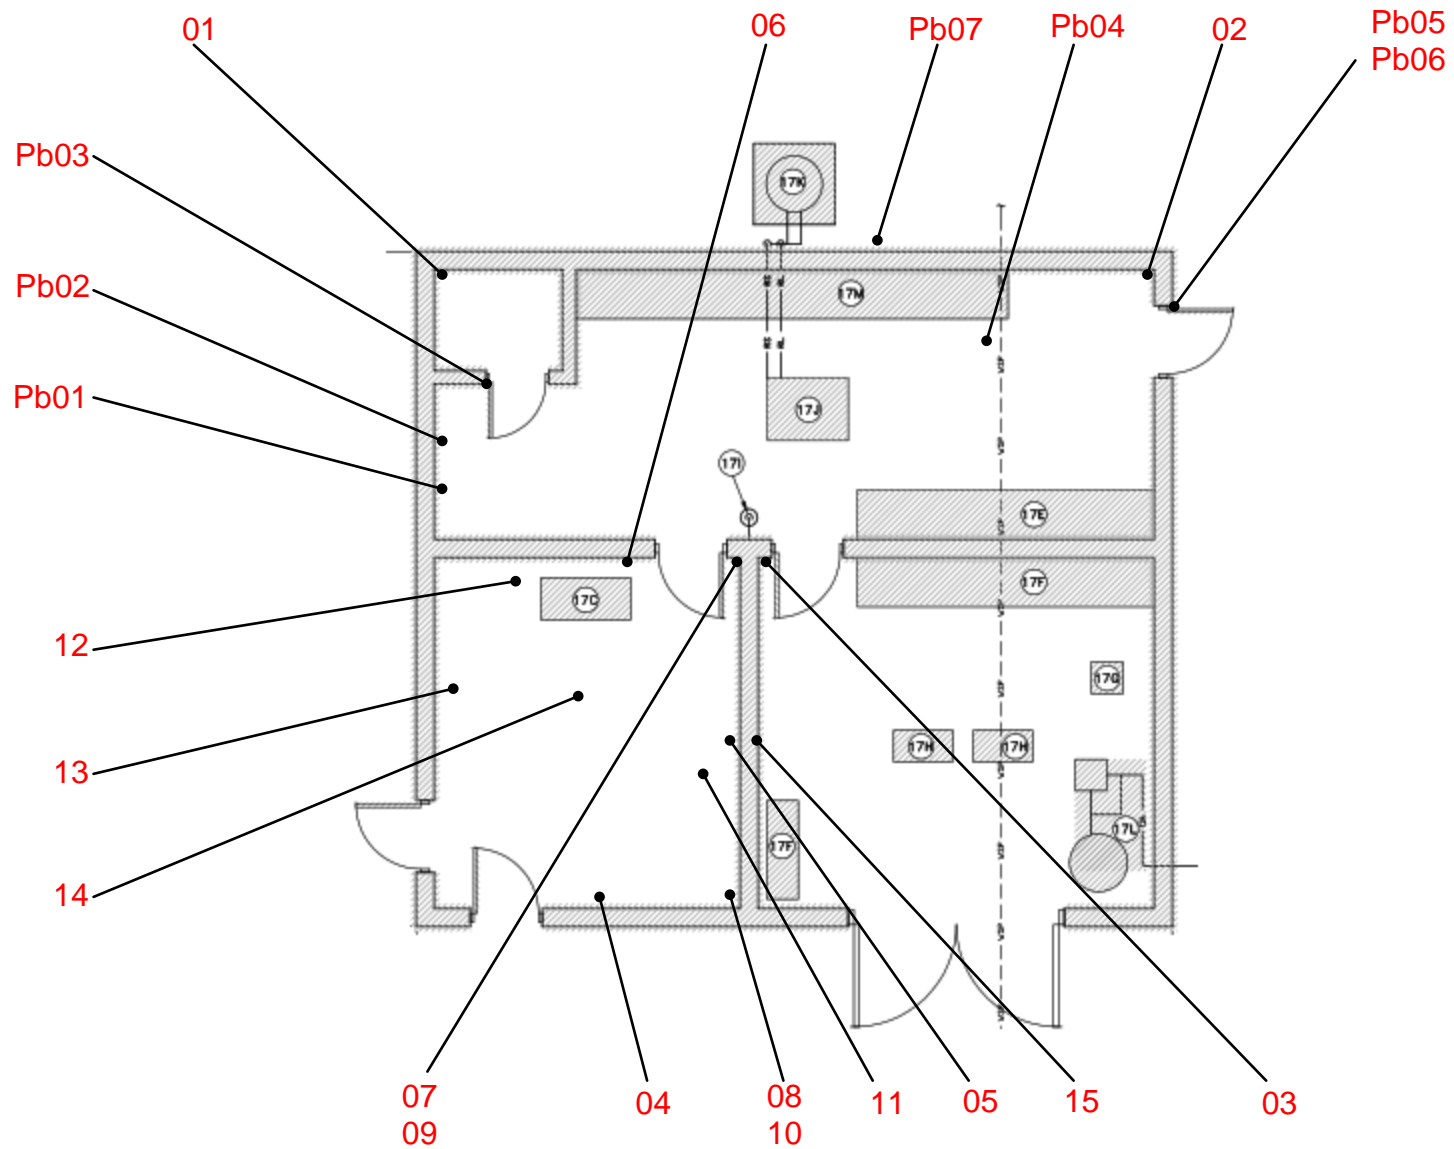
**SAMPLE LOCATION DRAWING**

Las Gallinas Valley Sanitary District  
 Demolition Plan Page MMD-3 (Control Building)  
 FACS # PJ38352  
 July 20, 2018 ADDENDUM 1

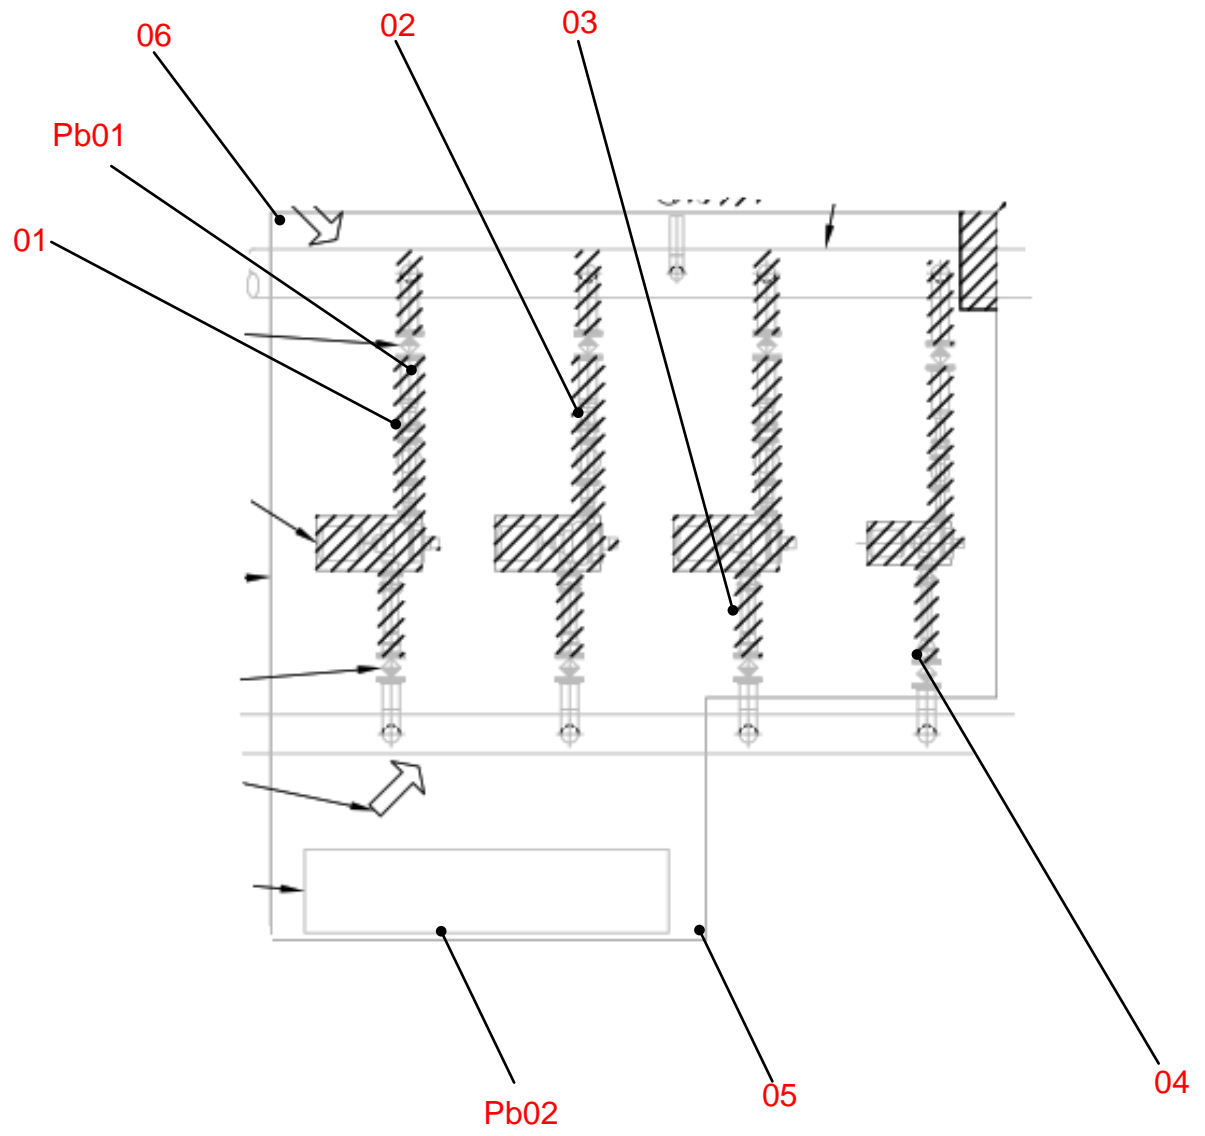
**SAMPLE LOCATION DRAWING**

Las Gallinas Valley Sanitary District  
 Demolition Plan Page MMD-6 (Pump Station)  
 FACS # PJ38352  
 July 20, 2018 ADDENDUM 1

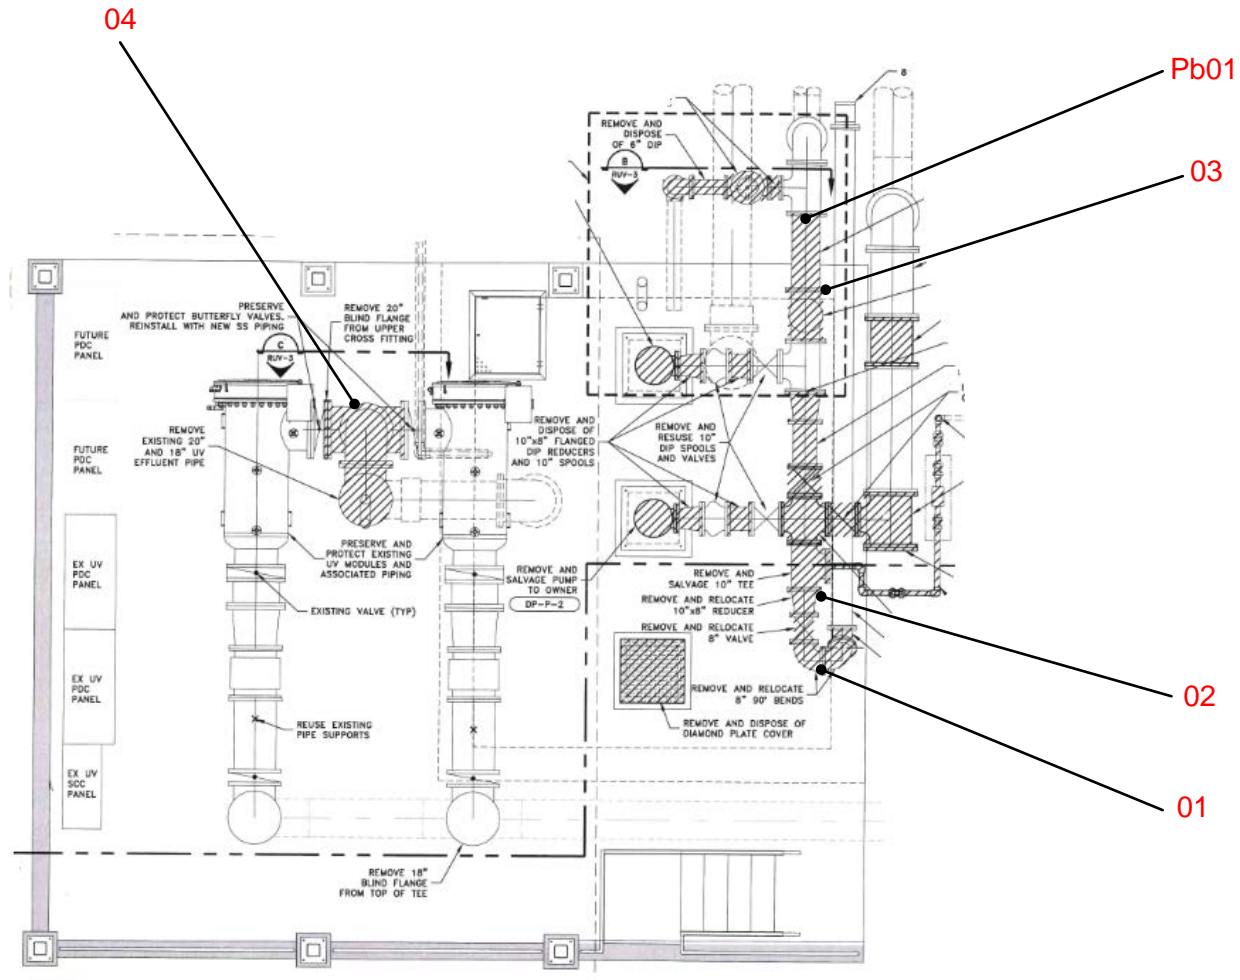
**SAMPLE LOCATION DRAWING**

Las Gallinas Valley Sanitary District  
 Demolition Plan Page RUV-1 (RWTF UV Disinfection)  
 FACS # PJ38352  
 July 20, 2018 ADDENDUM 1

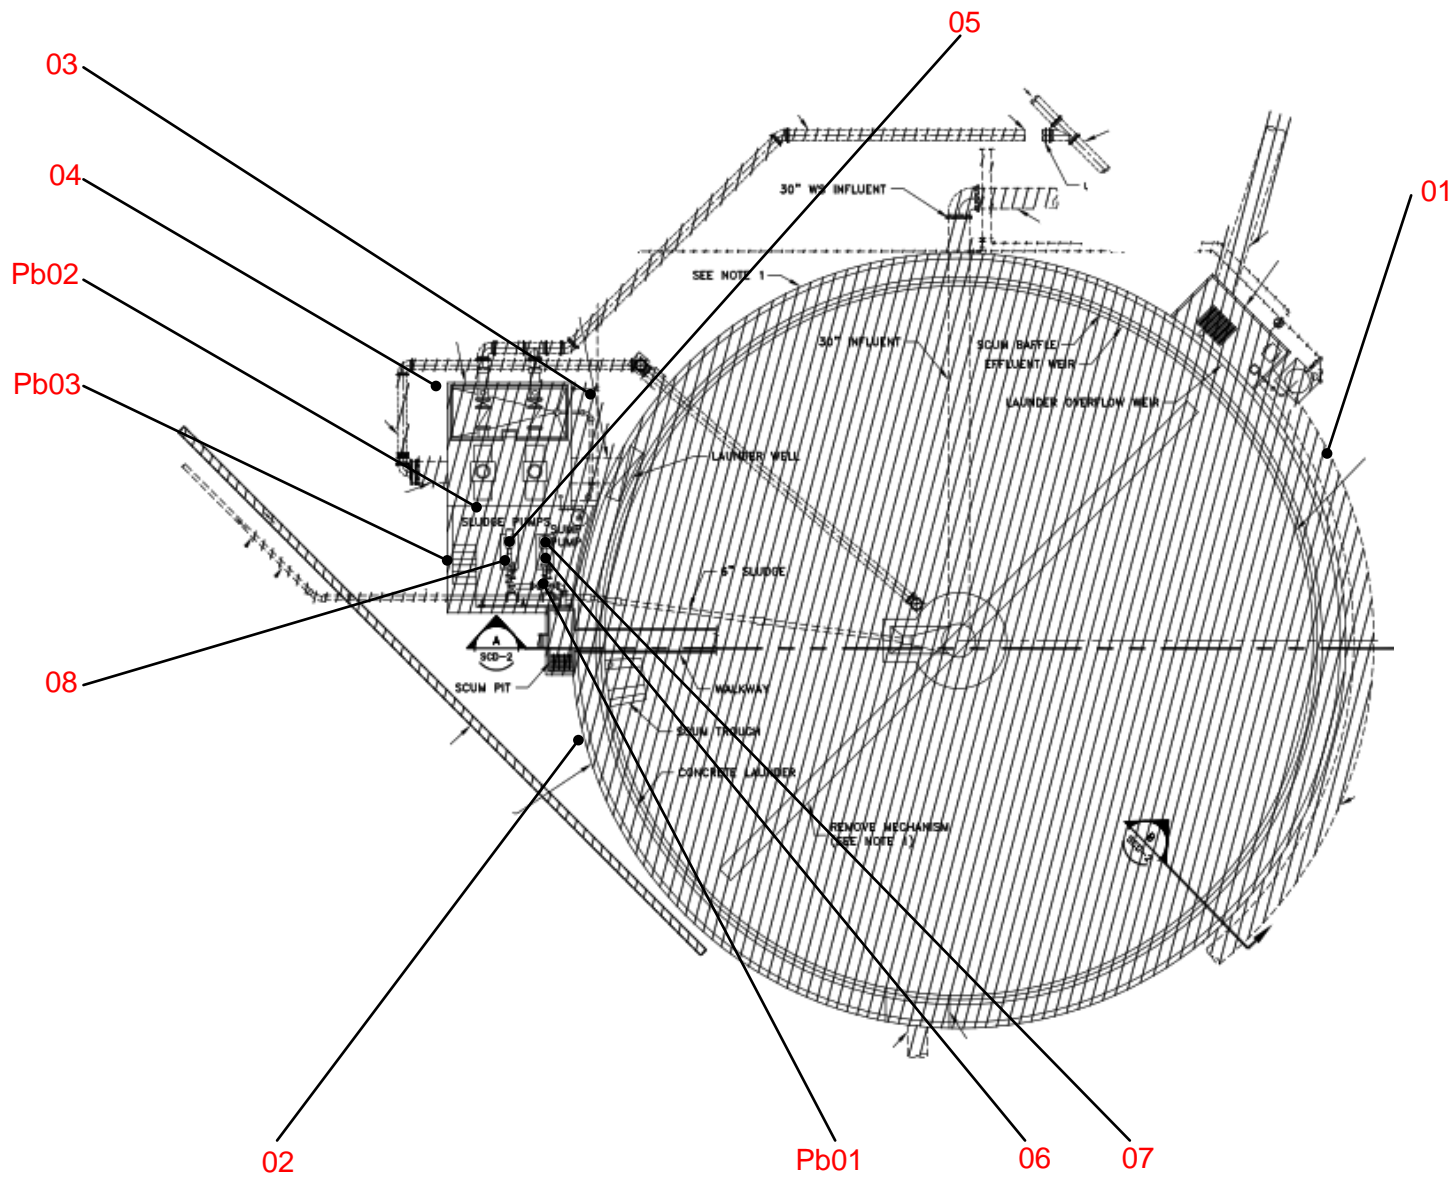
**SAMPLE LOCATION DRAWING**

Las Gallinas Valley Sanitary District  
 Demolition Plan Page SCD-1 (Existing Clarifier)  
 FACS # PJ38352  
 July 20, 2018 ADDENDUM 1

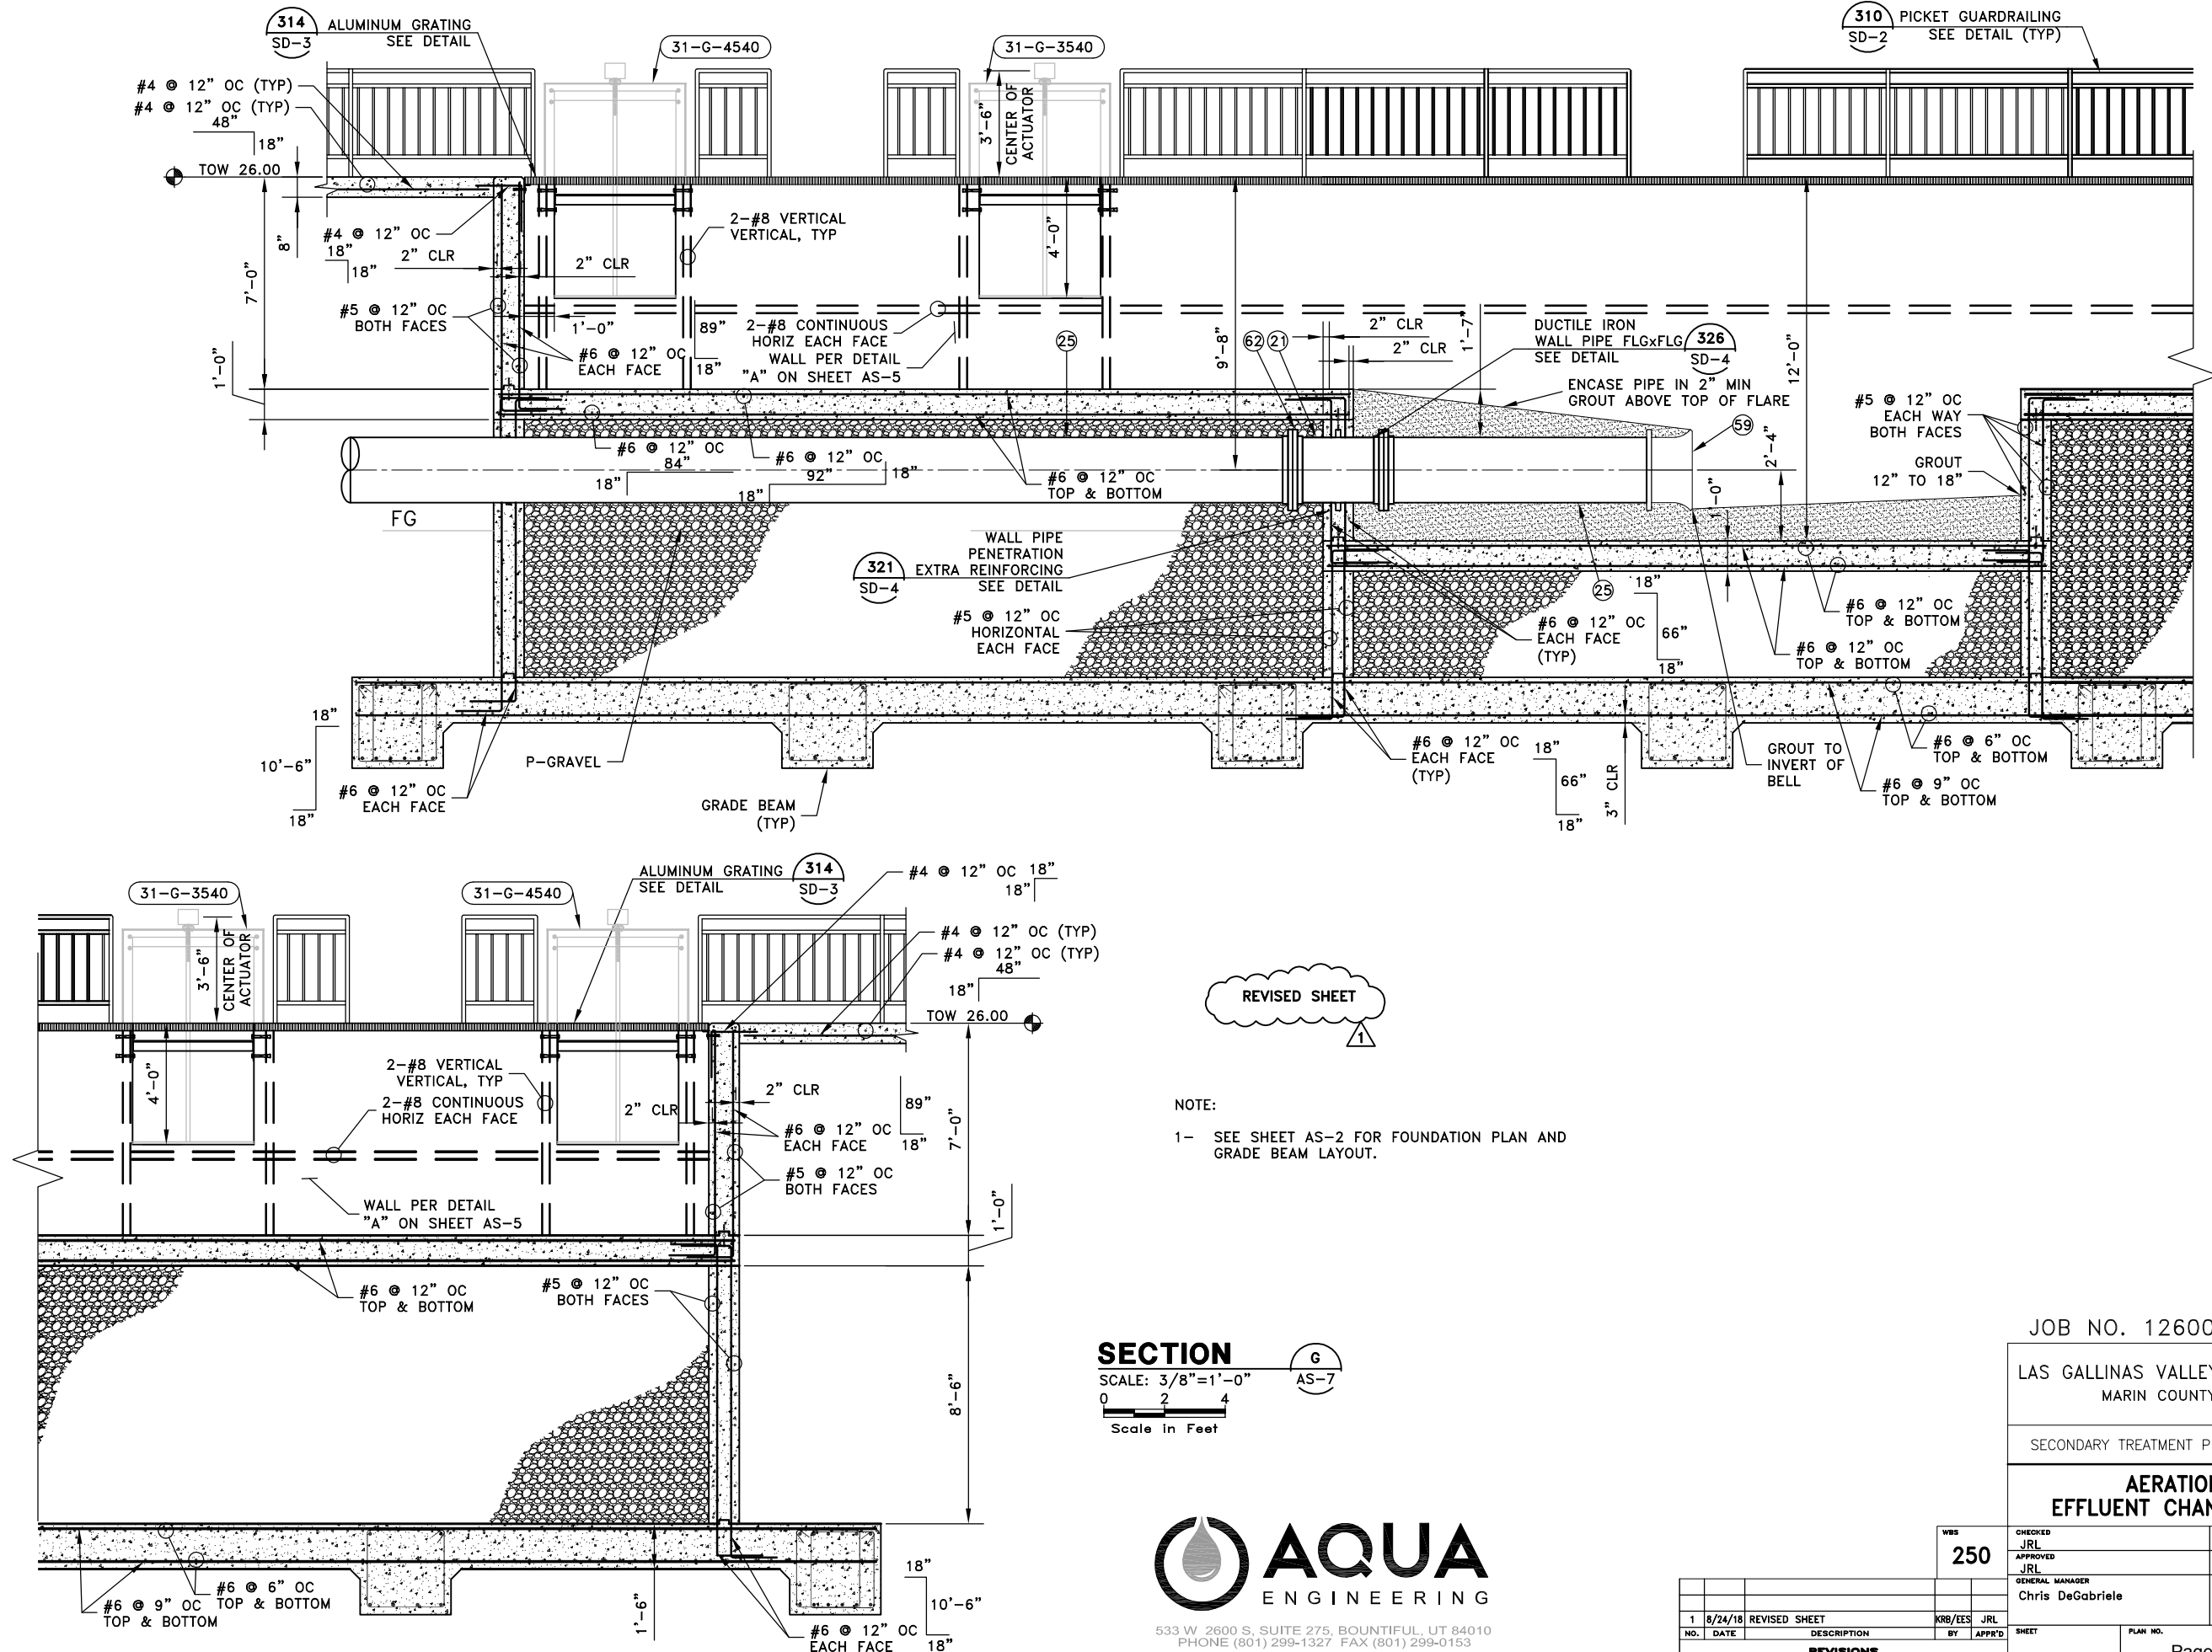
#### **Sheet AS-8**

8. Drawing AS-2 implies the grade beams from the Aeration Basin through the Effluent Channel remain at a constant elevation. Drawing AS-3, Sections A/B/C, all indicate the top of grade beam elevation to be 9.50 in the Aeration Basin. Drawing AS-8 indicates the top of the grade beam at elevation 14.0. Is there a transition detail missing for the grade beams transitioning from elevation 9.5 to 14.0 and back down to 9.5 as it moves across the channel? Is there a conflict between Section J & K/AS-9 and Section G/ AS-8?  
**The grade beams from the aeration basin into the effluent channel should remain at the same elevation as shown in Sections J and K on sheet AS-9. As discussed above, a revised version of Sheet AS-8 (with section G) is provided with this addendum.**
